Golder Associates

January 11th, 1982

Re: Geotechnical Appraisal for Proposed Subdivision
Halfmoon Bay, Sechelt, British Columbia

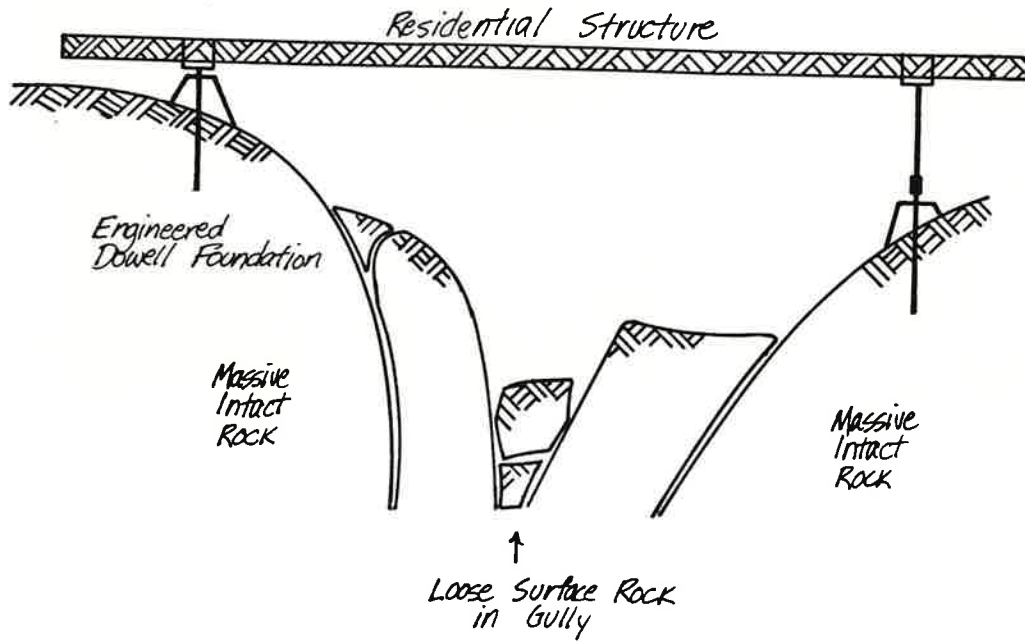
a) Loose Surface in Gully.

- (iii) Except where an individual rock terrace itself is unstable, see (d) below, a residential structure may be built on engineered dowell foundations, for example, and designed to span over loose surface rock in a gully, or to cantilever over loose surface rock at the toe of a terrace. Such designs should be approved by an engineer, and examples are shown in Figure 2.

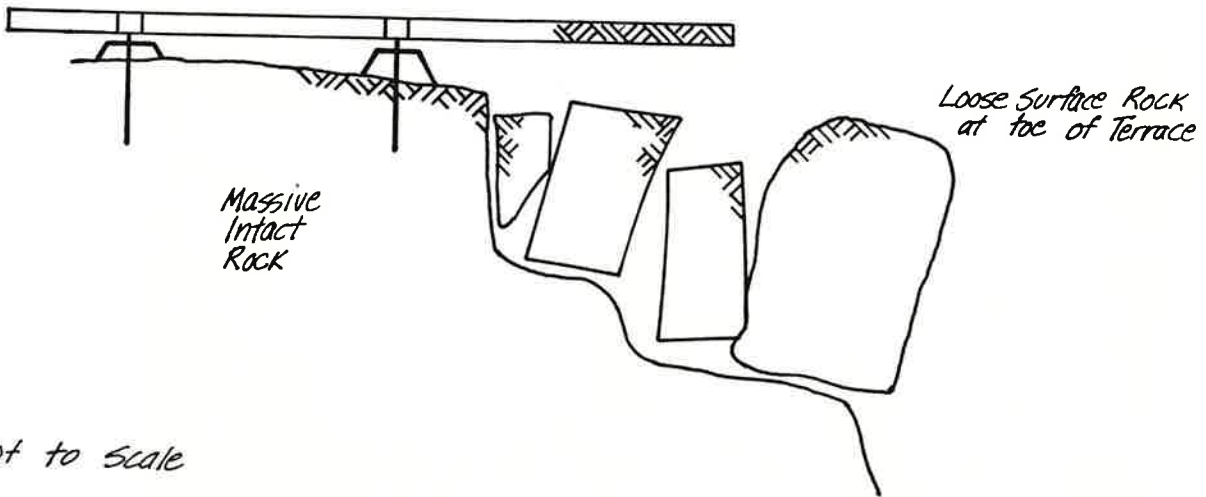
b) Loose Surface at Toe of Terrace.

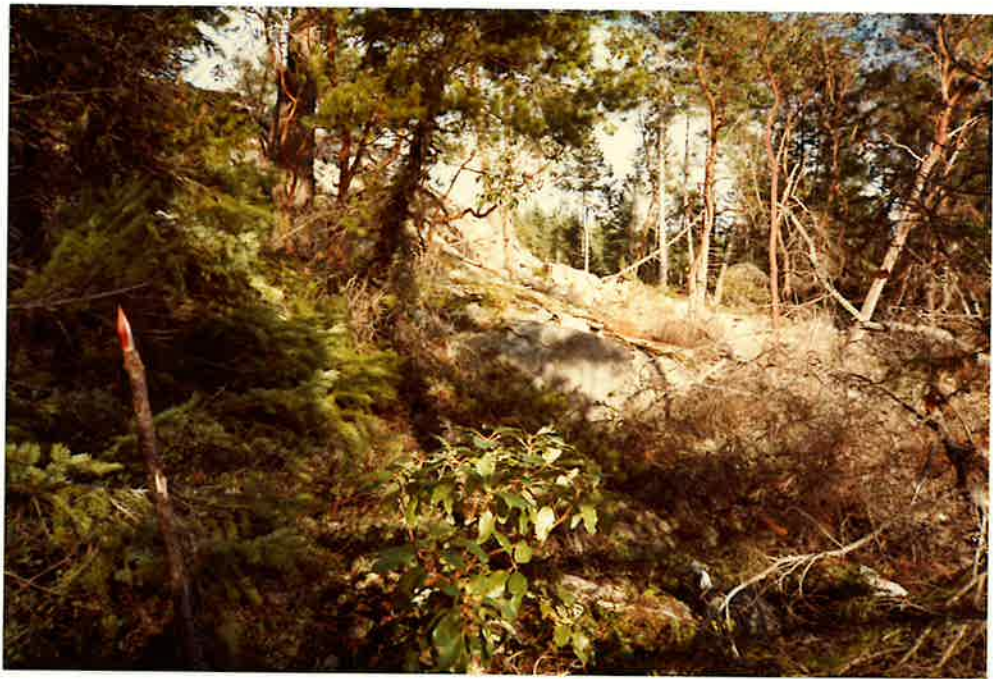
Photograph 1

Irregular blocky ground below fill

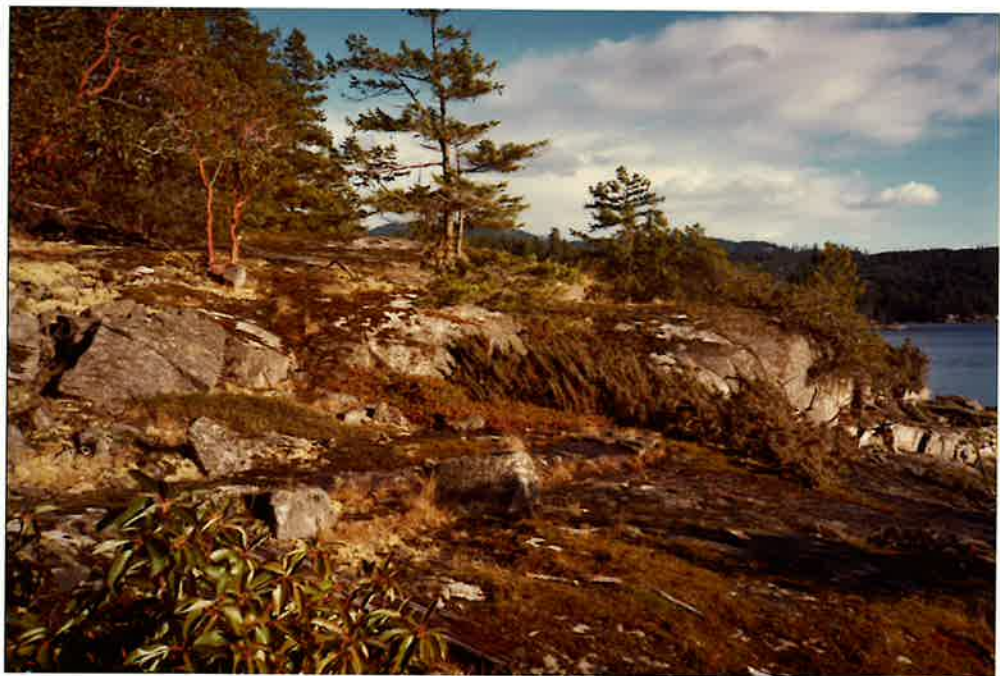
Photograph 2

Rounded, glacially eroded shoreline, locally broken

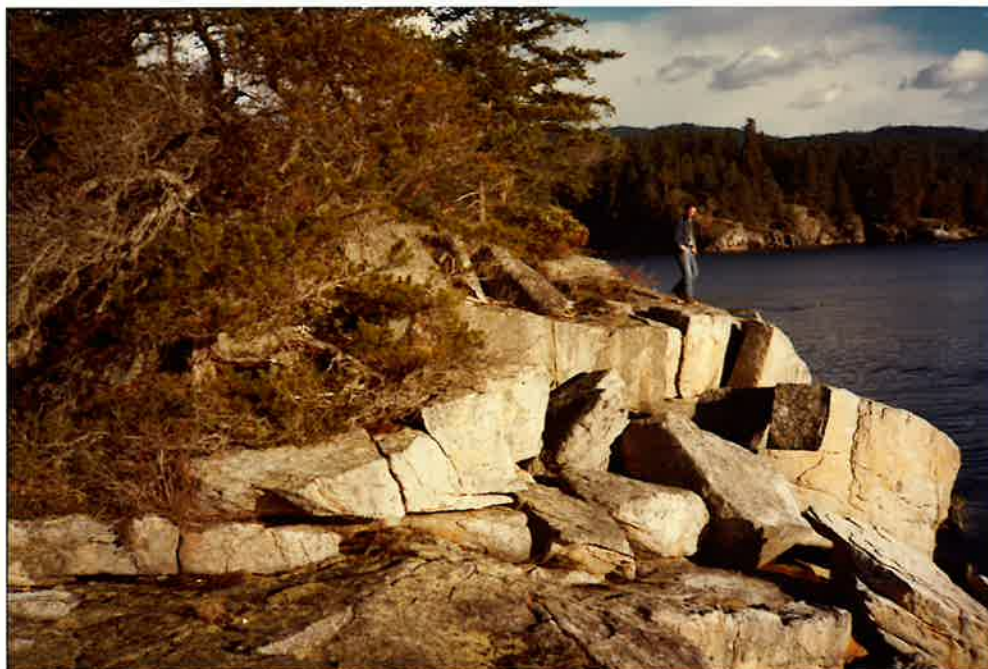
Photograph 3

Very blocky shoreline, within Regional District set back

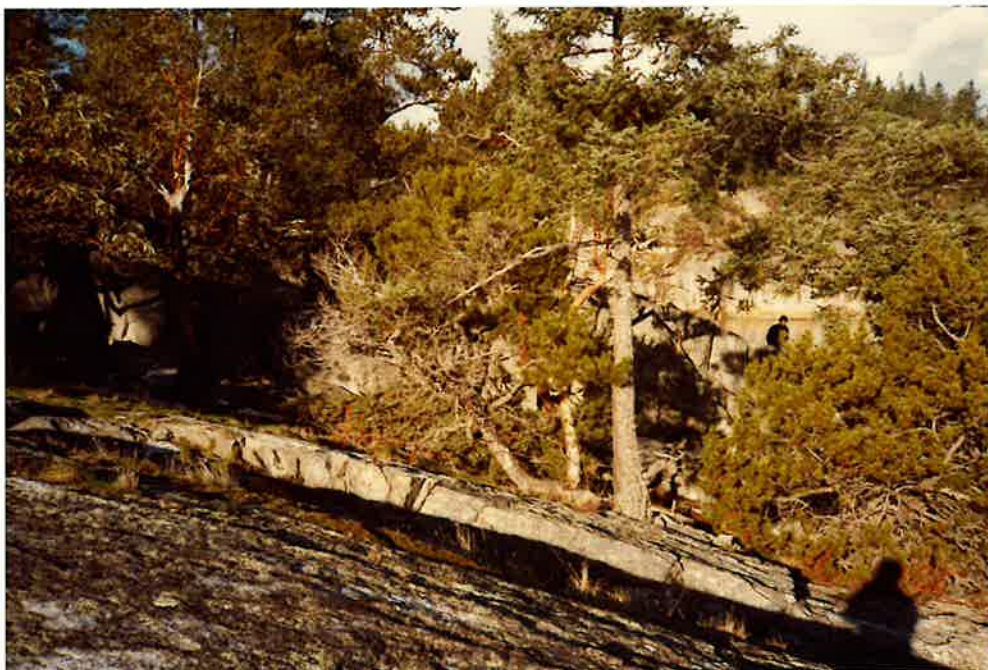
Photograph 4

Clean, eroded shoreline

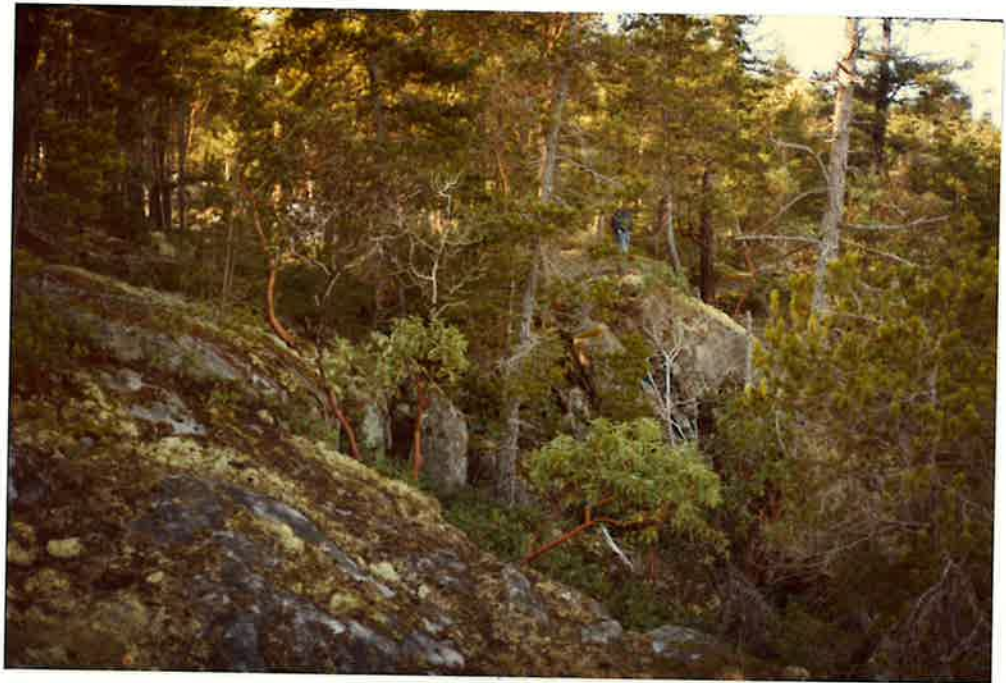
Photograph 5

Rounded bluffs with broken gully between

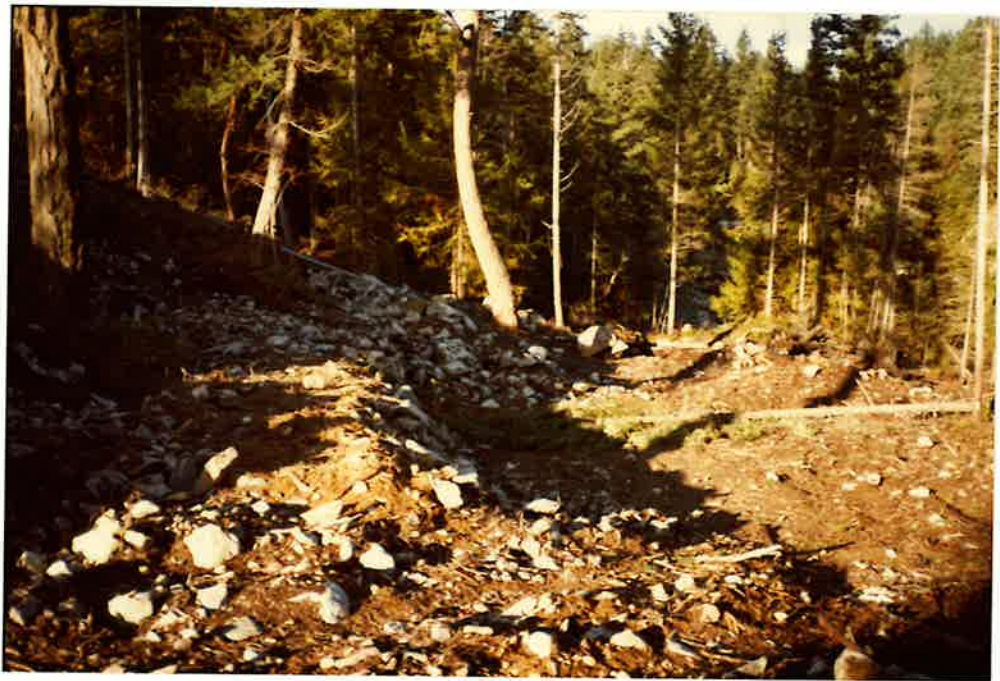
Photograph 6

Fill and blasted rock below access road

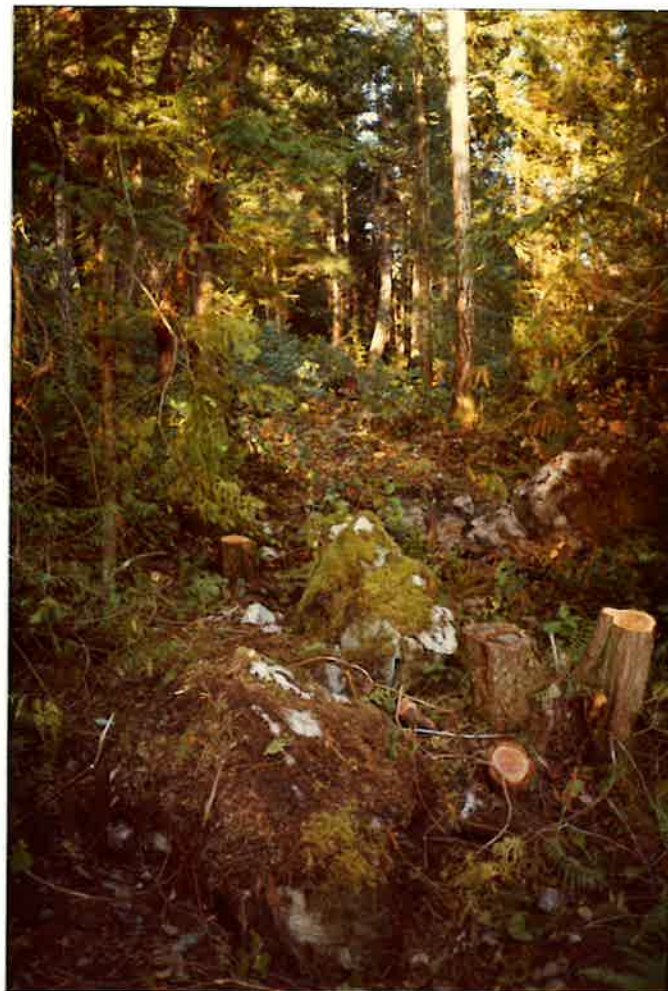
Photograph 7

Broken ground at toe of slope

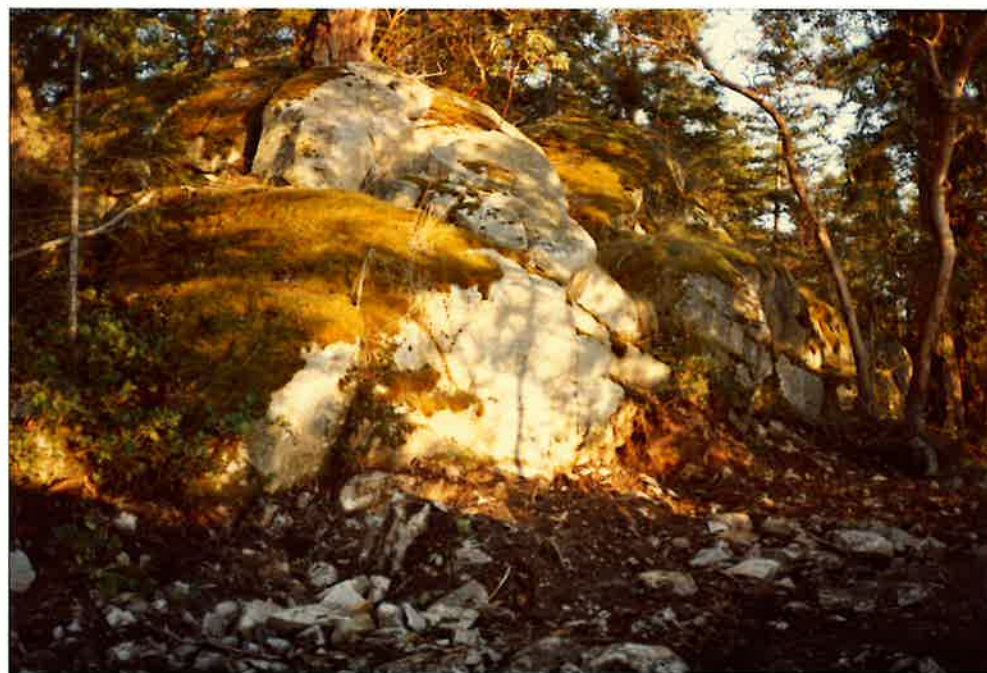
Photograph 8

Marginally stable block (broken by tree roots) within
Regional District set back

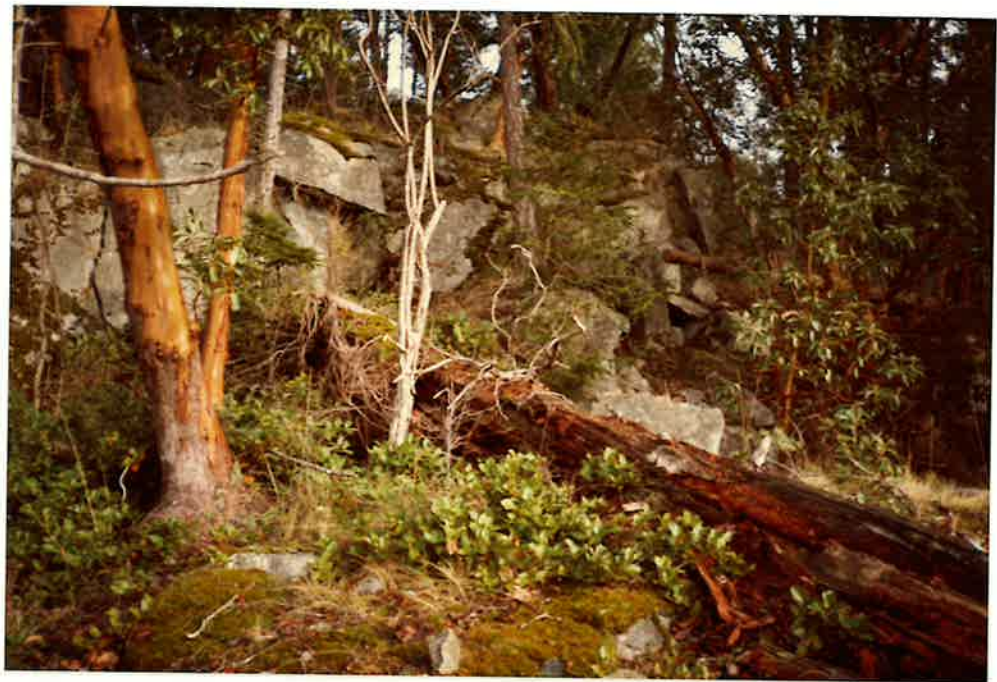
Photograph 9

Loose surface rock at toe of terrace

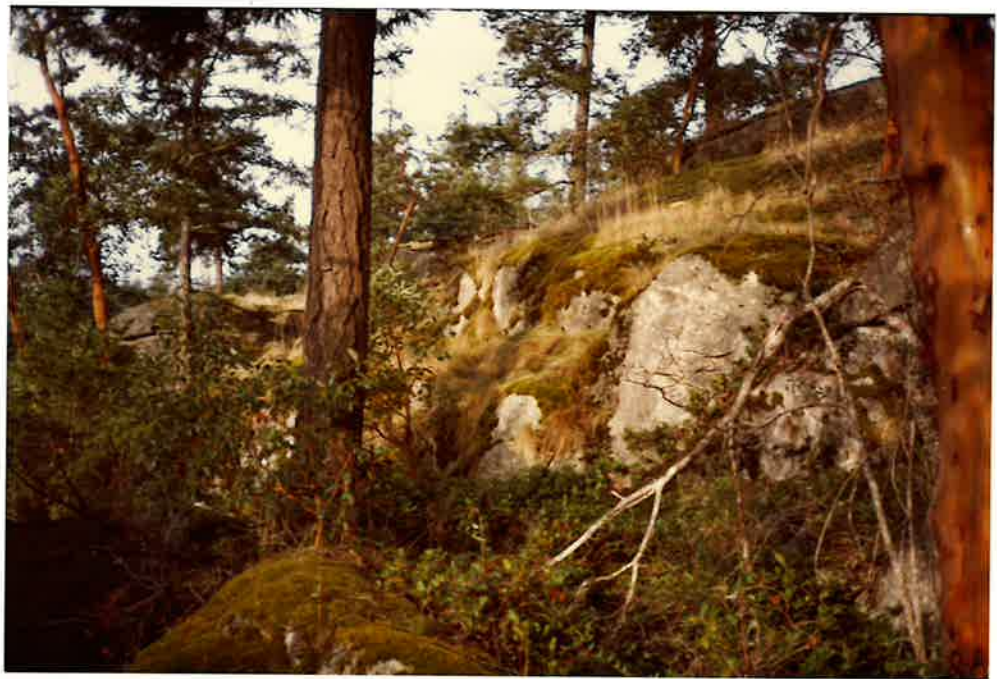
Photograph 10

Minor loose surface rock on terrace

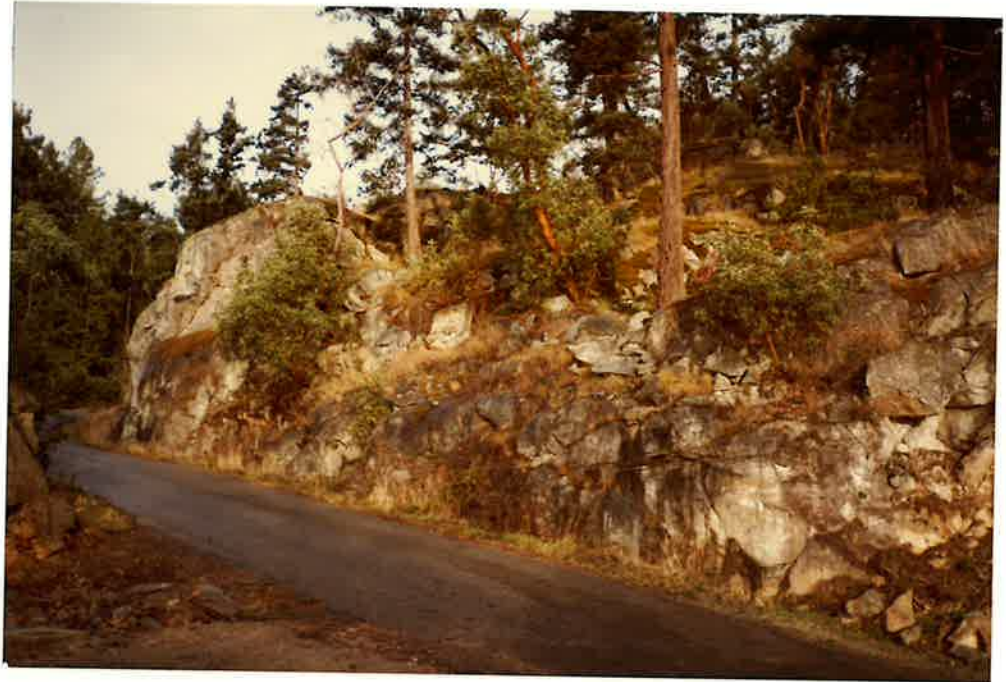
Photograph 11

Overall view of stable rock mass

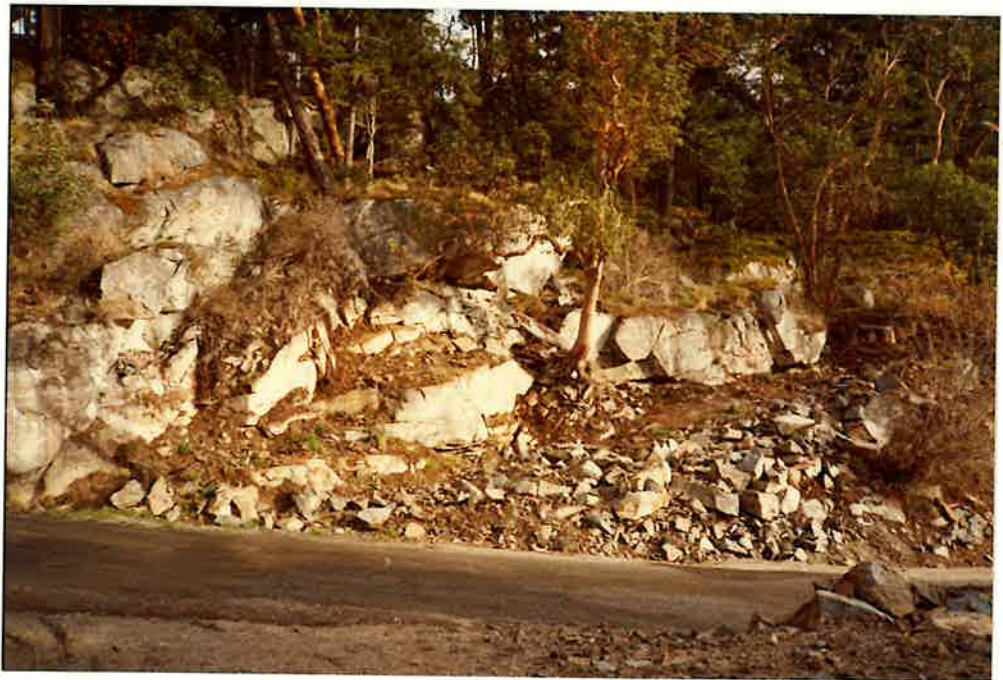
Photograph 12

Individual lot access development

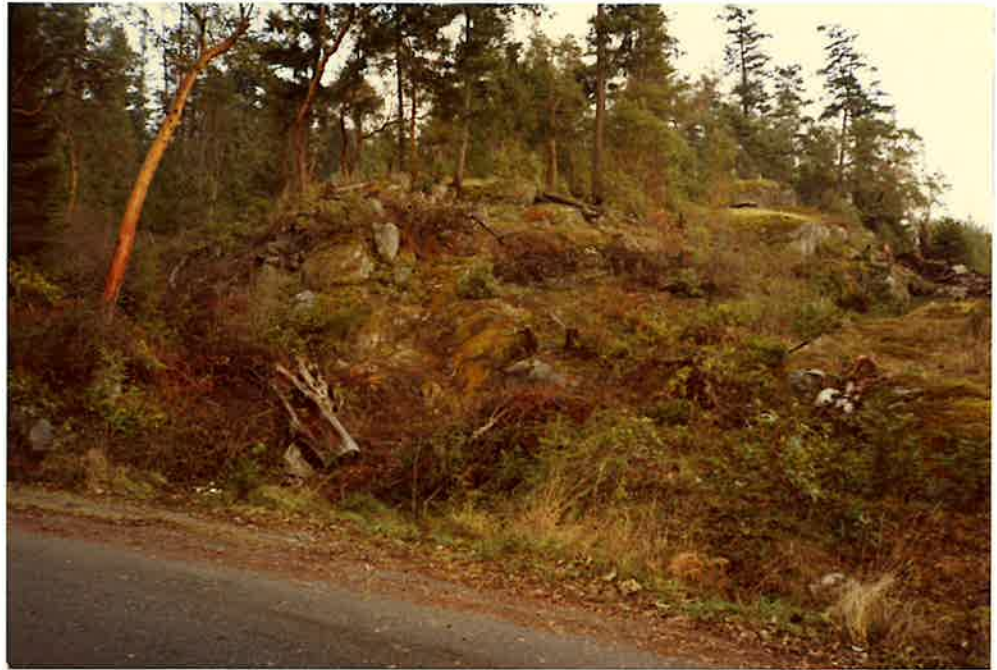
Photograph 13

View of cleared stable rock terraces

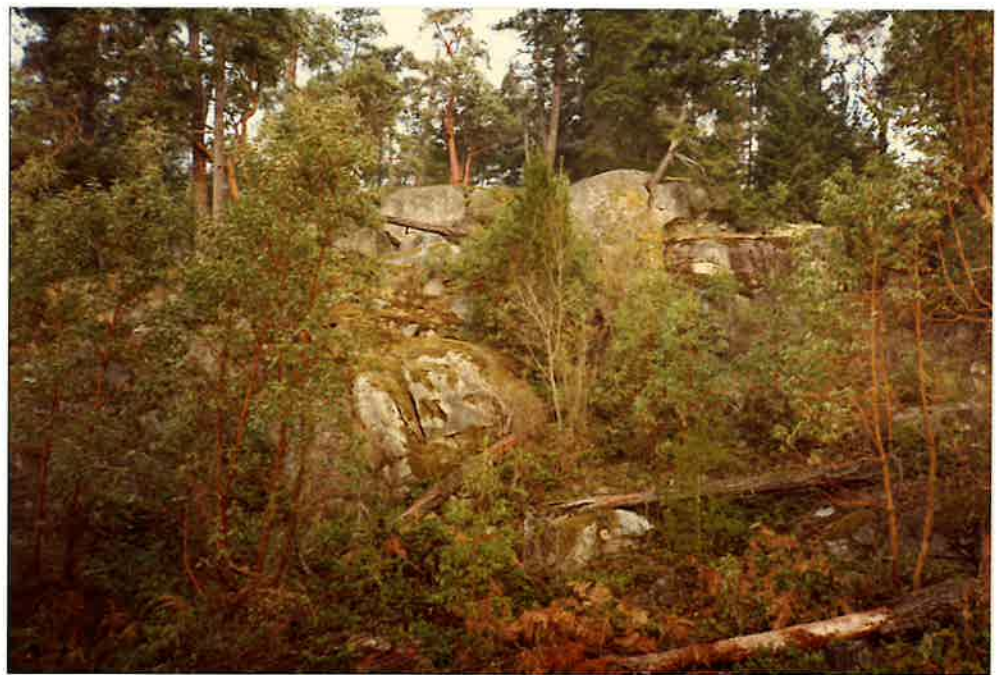
Photograph 14

General view of rounded rock terraces, with some local loose surface rock

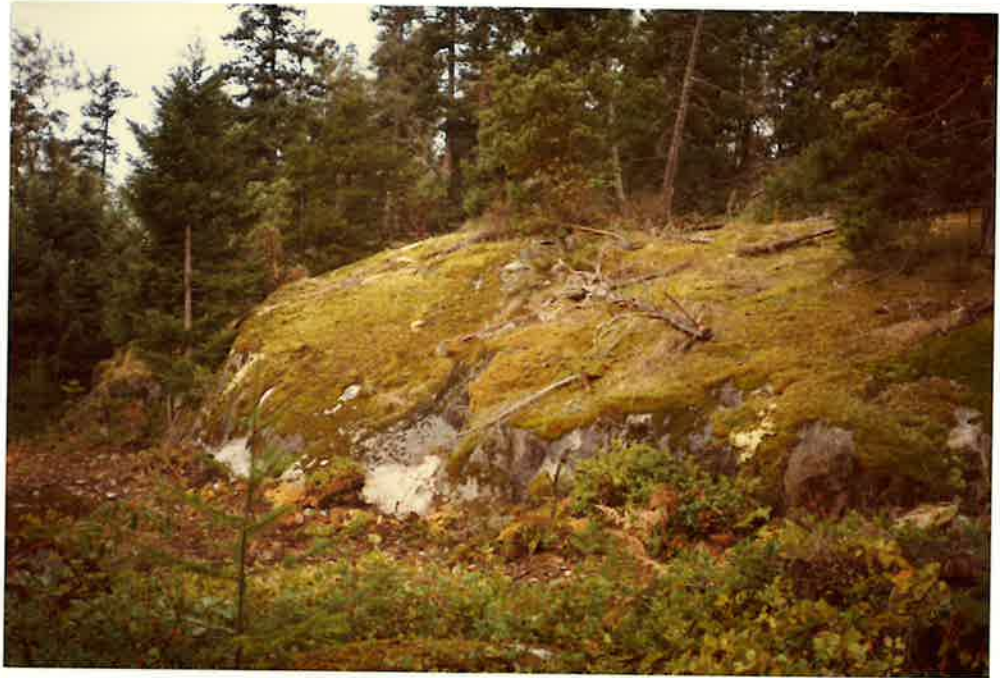
Photograph 15

Stable, smooth, glacially eroded terrace

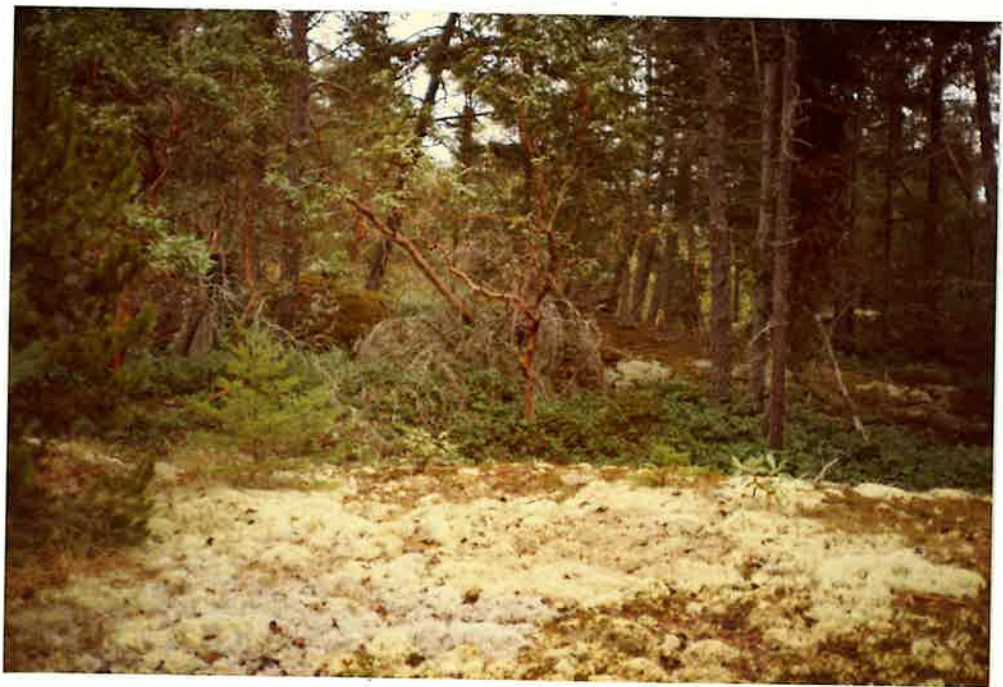
Photograph 16

Flat, clean rock outcrop

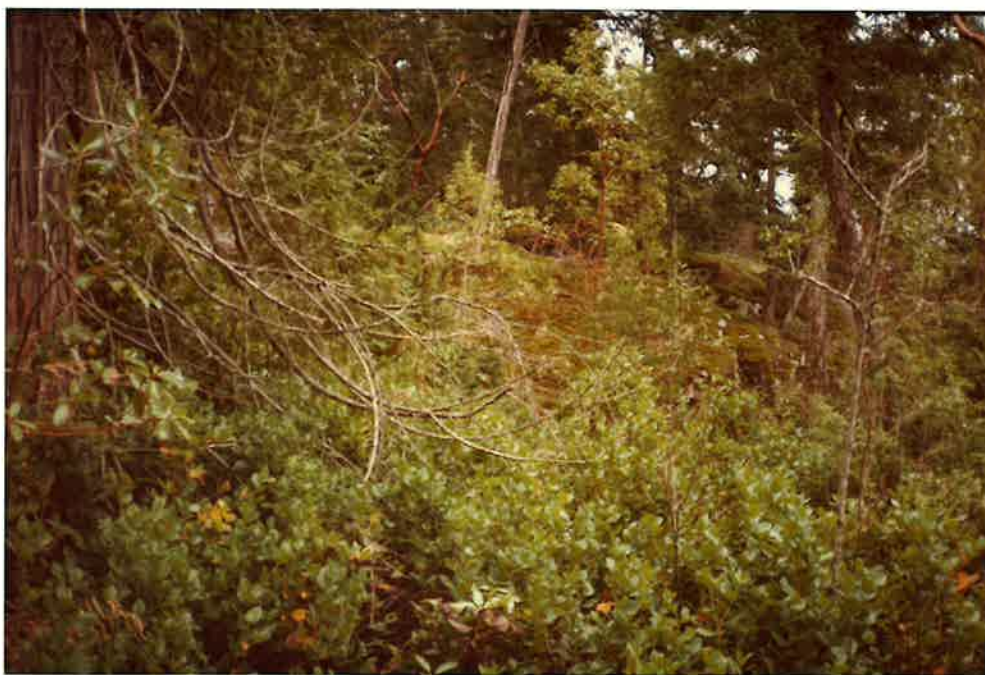
Photograph 17

Dense salal over rock outcrop

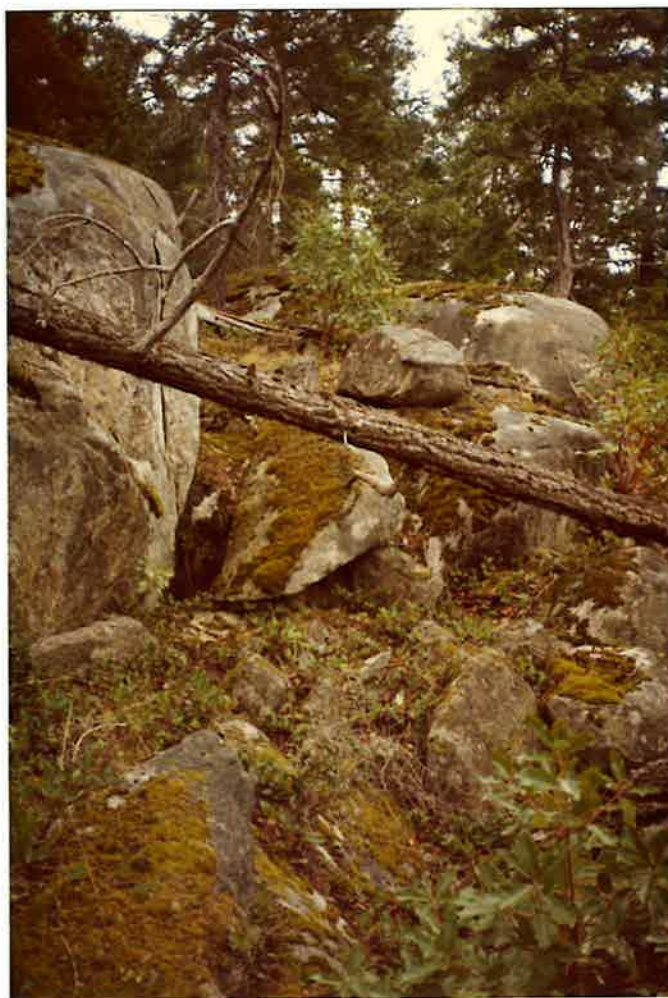
Photograph 18

Loose surface rock from stress relief jointing

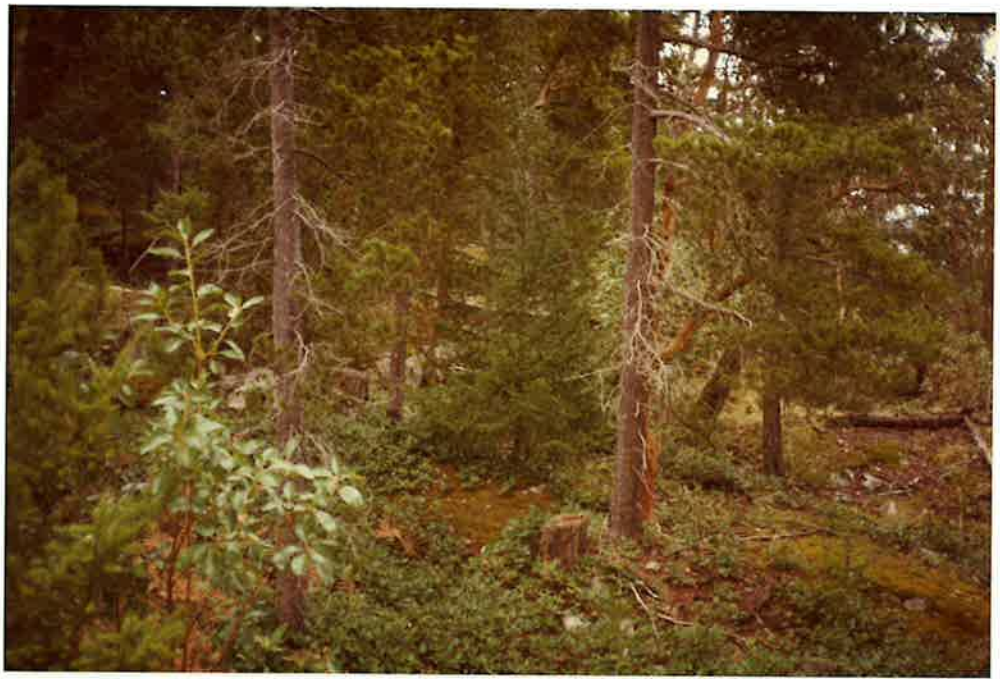
Photograph 19

Flat lying, shallow terraces, some loose surface

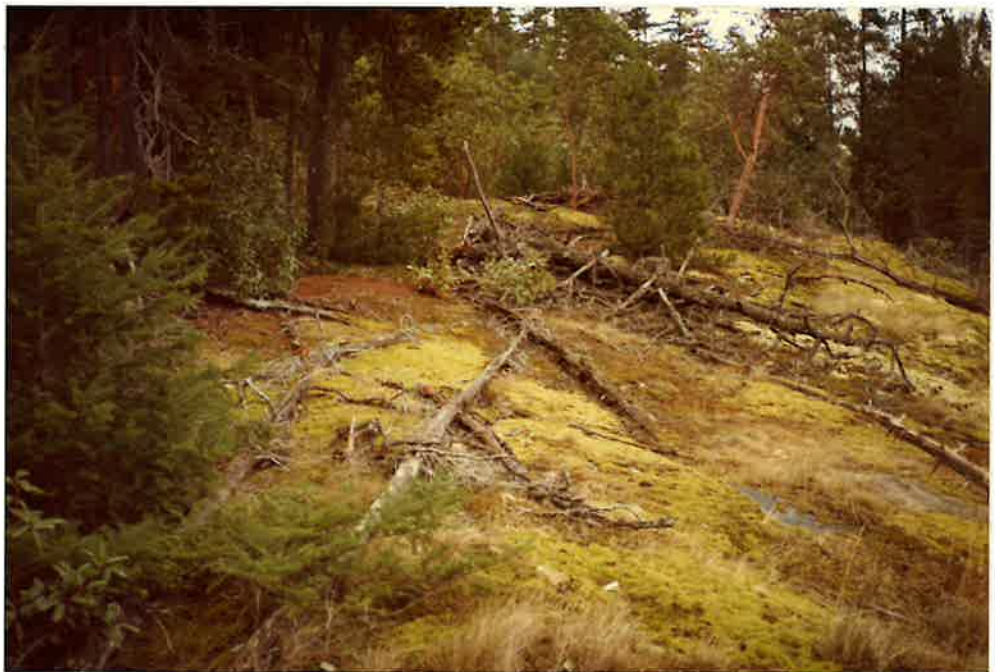
Photograph 20

Uniform, clean, smooth slope

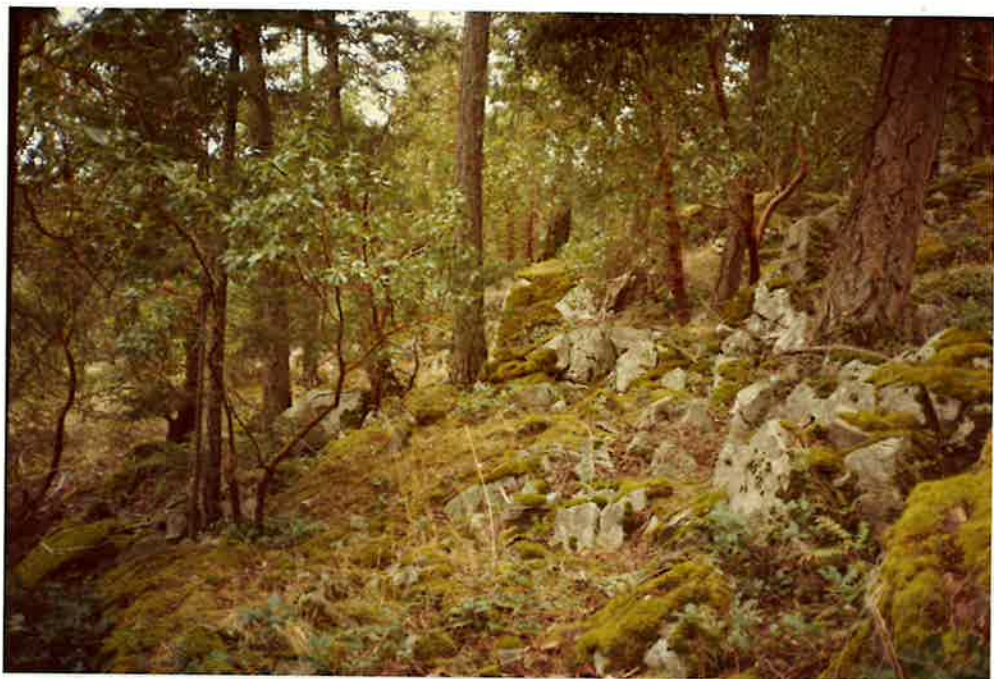
Photograph 21

Broken ground on 25 degree slope

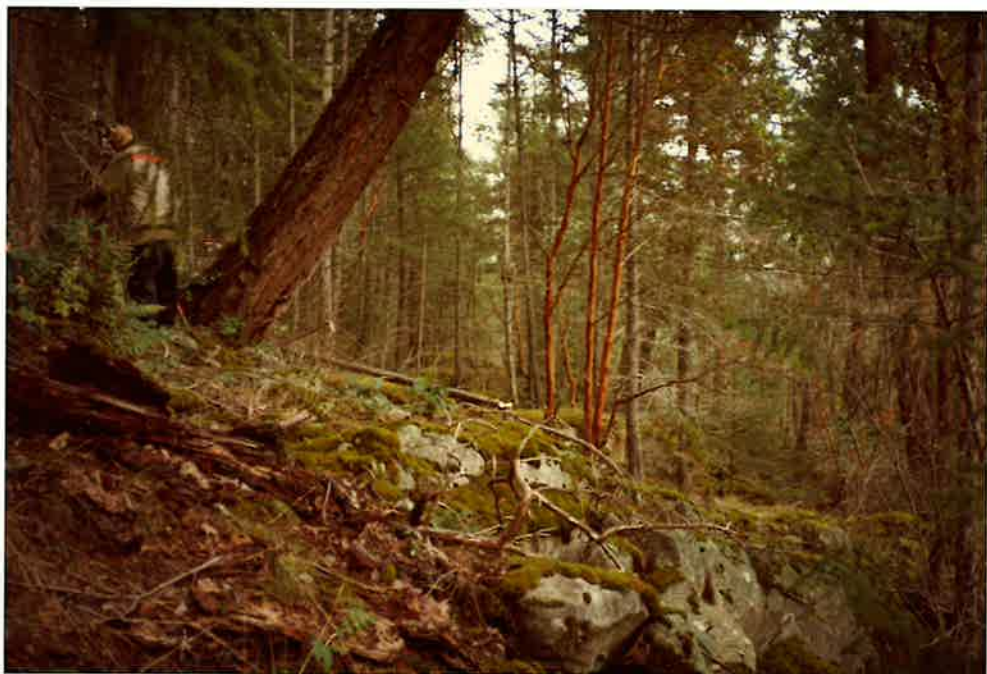
Photograph 22

Loose, surface rock below terrace

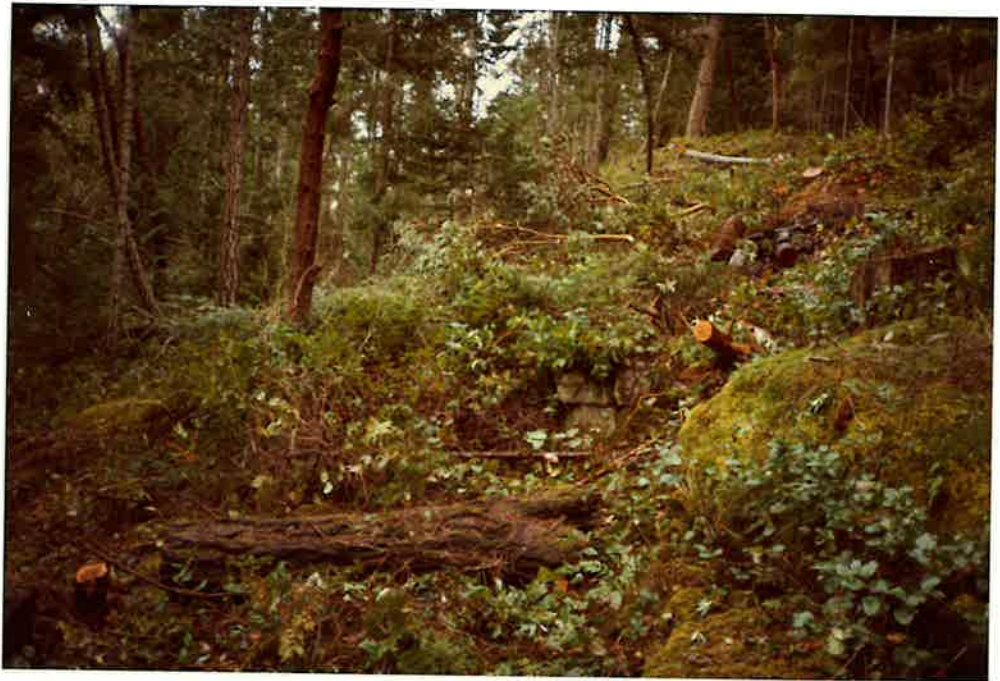
Photograph 23

Broken ground, heavily overgrown

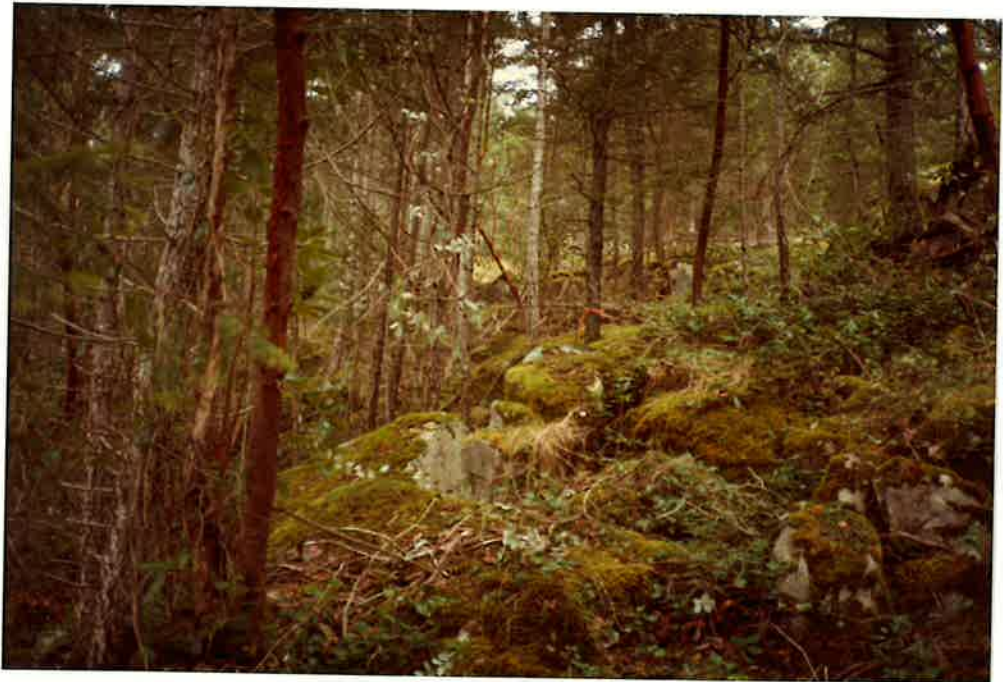
Photograph 24

Broken ground, photograph along back line of property

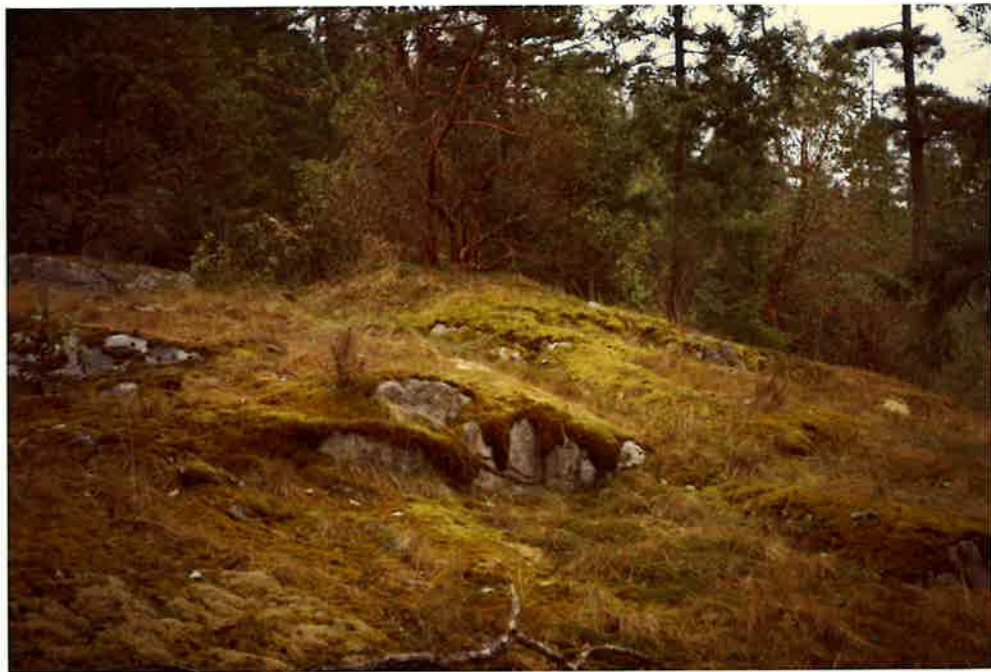
Photograph 25

Rounded, clean rock terraces

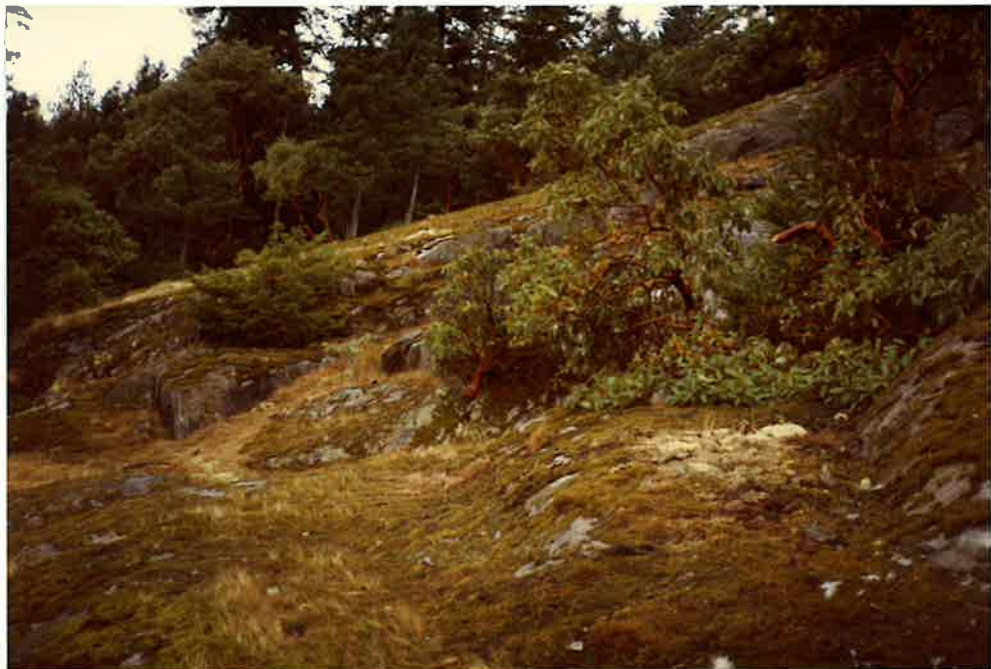
Photograph 26

Clean, eroded rock terrace to Square Bay

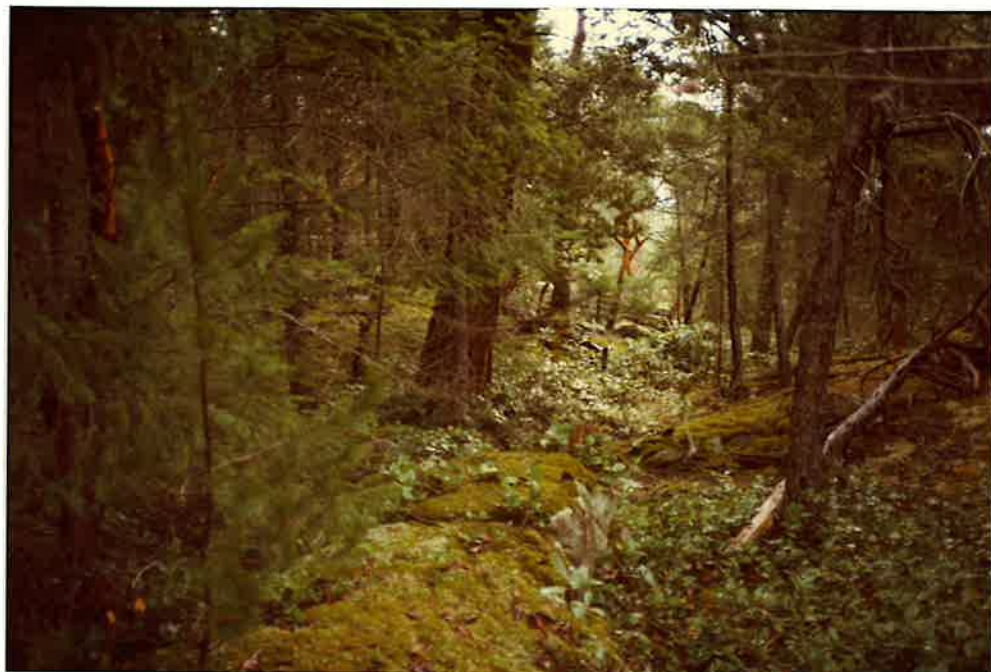
Photograph 27

Flat surface at crest of terrace

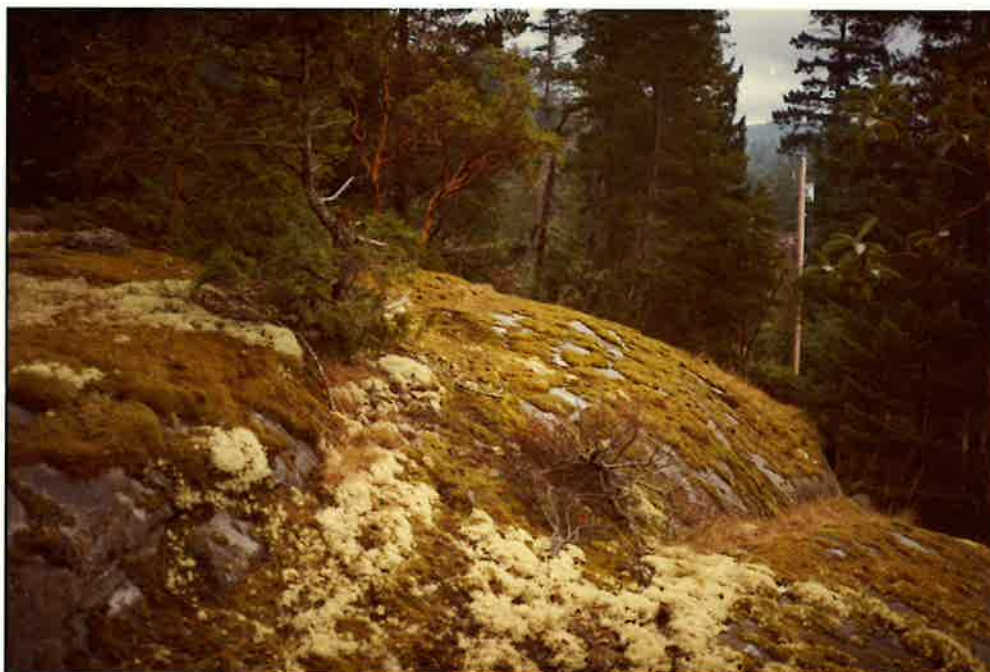
Photograph 28

Smooth, clean eroded terrace

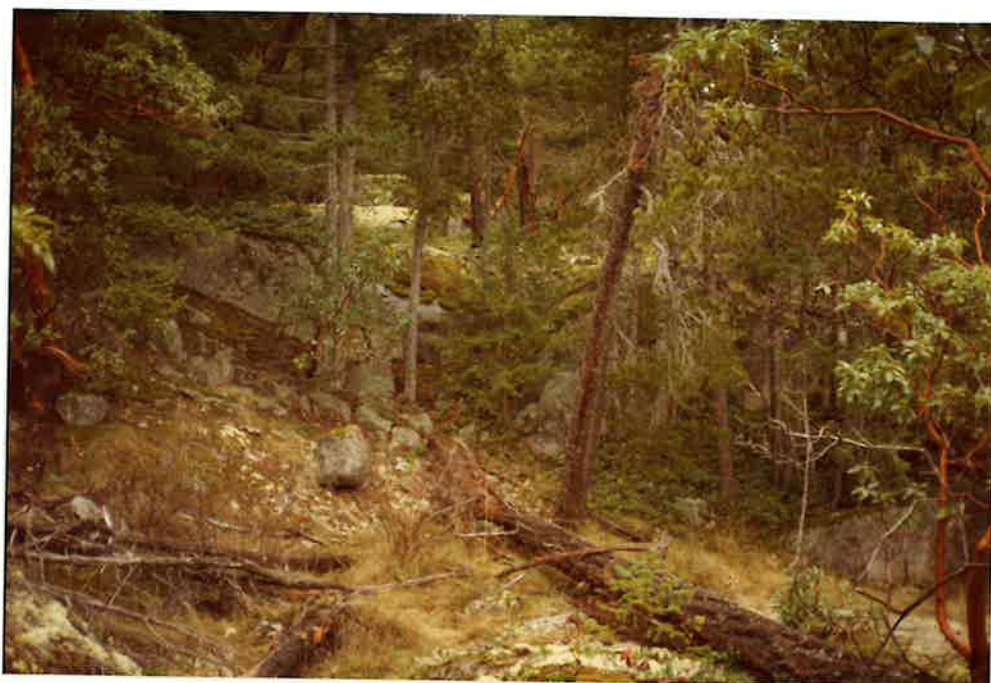
Photograph 29

Shallow hollow with some loose surface

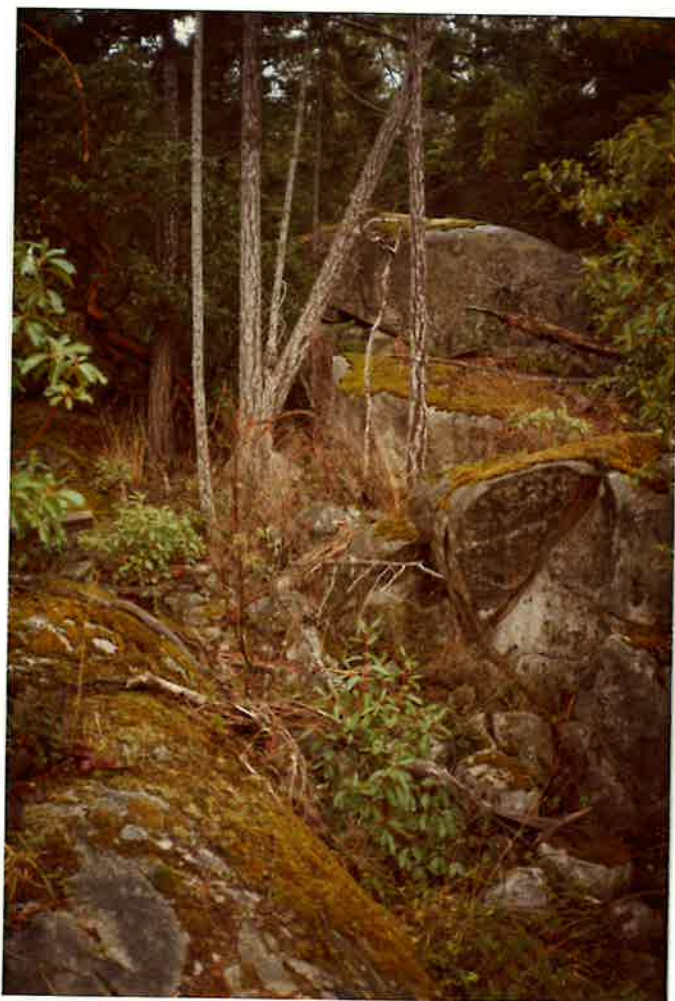
Photograph 30

Hummocky ground, stable with some loose surface

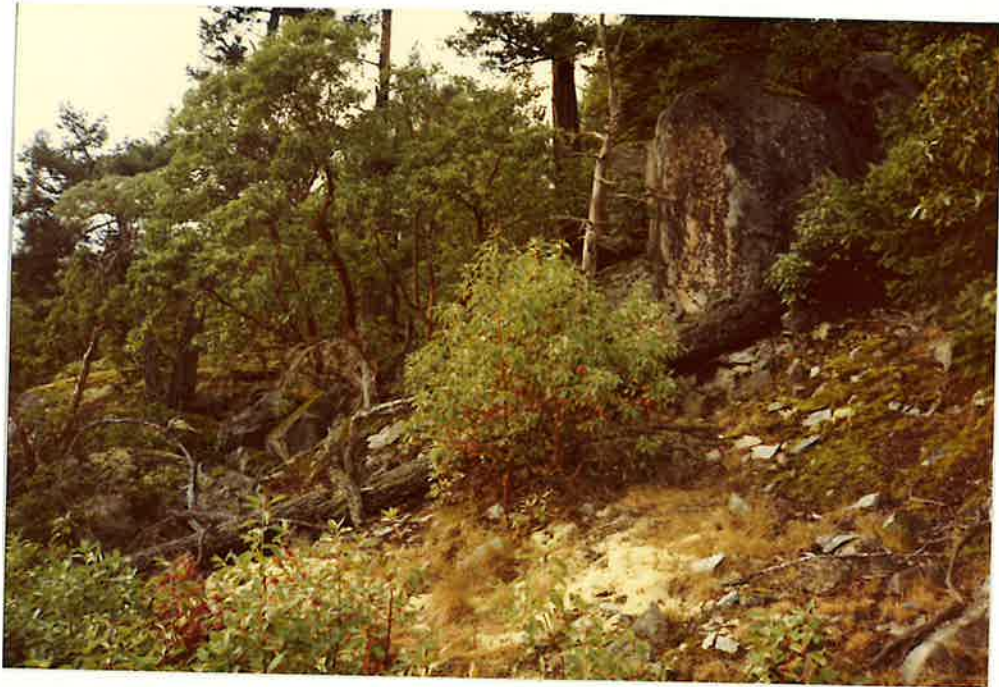
Photograph 31

Blocky ground with loose surface below smooth terrace
