September 10, 2022

GES Project No. 22011

Re: **FOLLOW-UP GEOTECHNICAL & HAZARD ASSESSMENT REPORT
UNDEVELOPED PROPERTY
TRUMAN ROAD, HALFMOON BAY, BC**

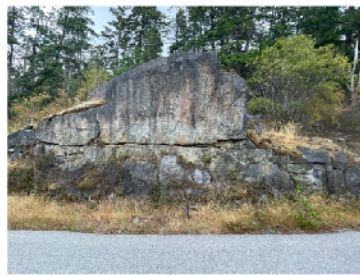
2 Rock scarps. Evidence of significant potential for a future rock slide.

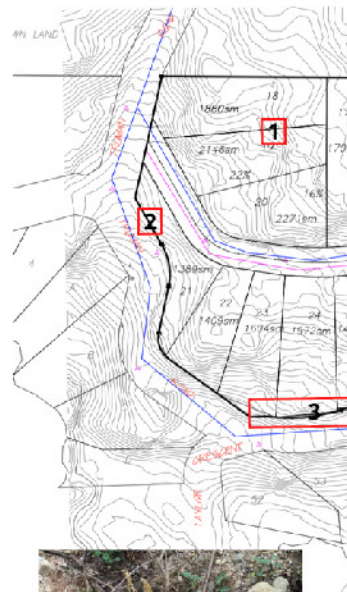
3 Rock scarps. Evidence of significant potential for a future rock slide. Joints present (Marked pink on the previous plan provided by GES, June 24, 2022)

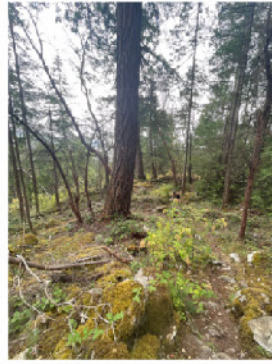
historical rock sliding and general ground movement. The subsoils of these two test pits consisted of sands, gravels, and cobbles; see Photos 5 and 6 in Figures 2-3. Later, based on anecdotal information received from Will Dong (PEng), we were made aware that these test pits were dug to complete percolation testing.

5 Excavation pit (done by others) consisting of cobbles, gravels and sands.

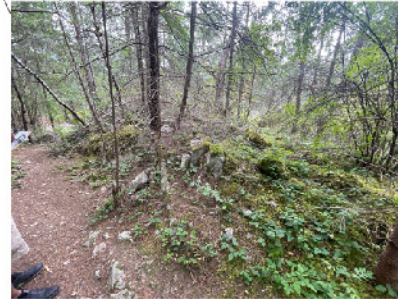
6 Excavation pit. (done by others). Consisting of cobbles, gravels and sands.

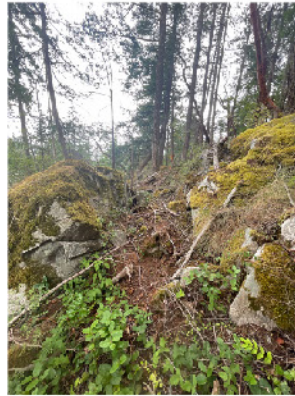
10 Gully featuring remnant boulders from previous rock sliding

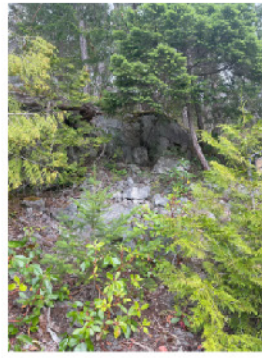
9 Broken rocks from previous rock sliding

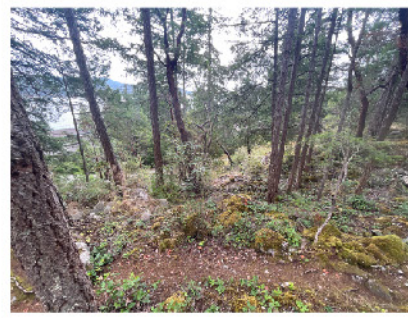
8 Rock outcrops

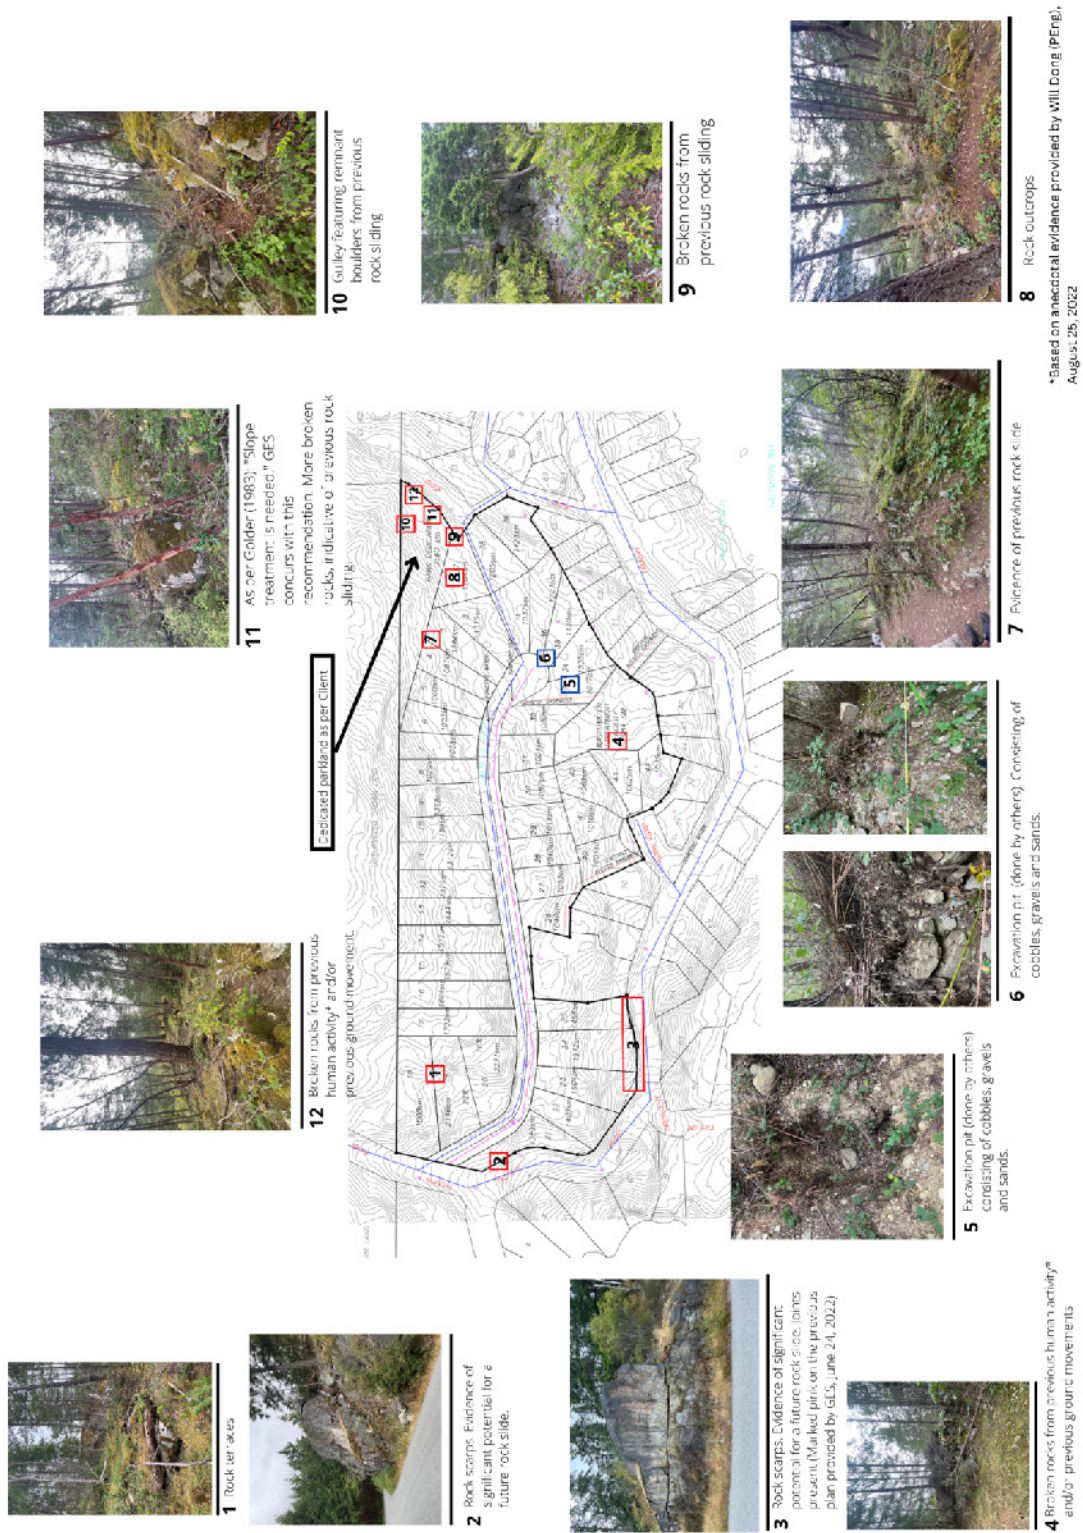
Figure 4: Map of the subject site (incorporating Figures 1-3).
Overlay done by GES.

We started our August 3 site visit by carrying out a walkover survey along Ross Road; see Figure 2. Once we reached the end of the subject property line, we hiked up to investigate the upper lots; see Figure 3. After that, we went over the lots along Truman Road; see Figure 1. Figure 4 shows the information included in Figures 1, 2 and 3, thus easing reference to all the pertinent geotechnical information collected and summarised from our August 3 detailed site reconnaissance.

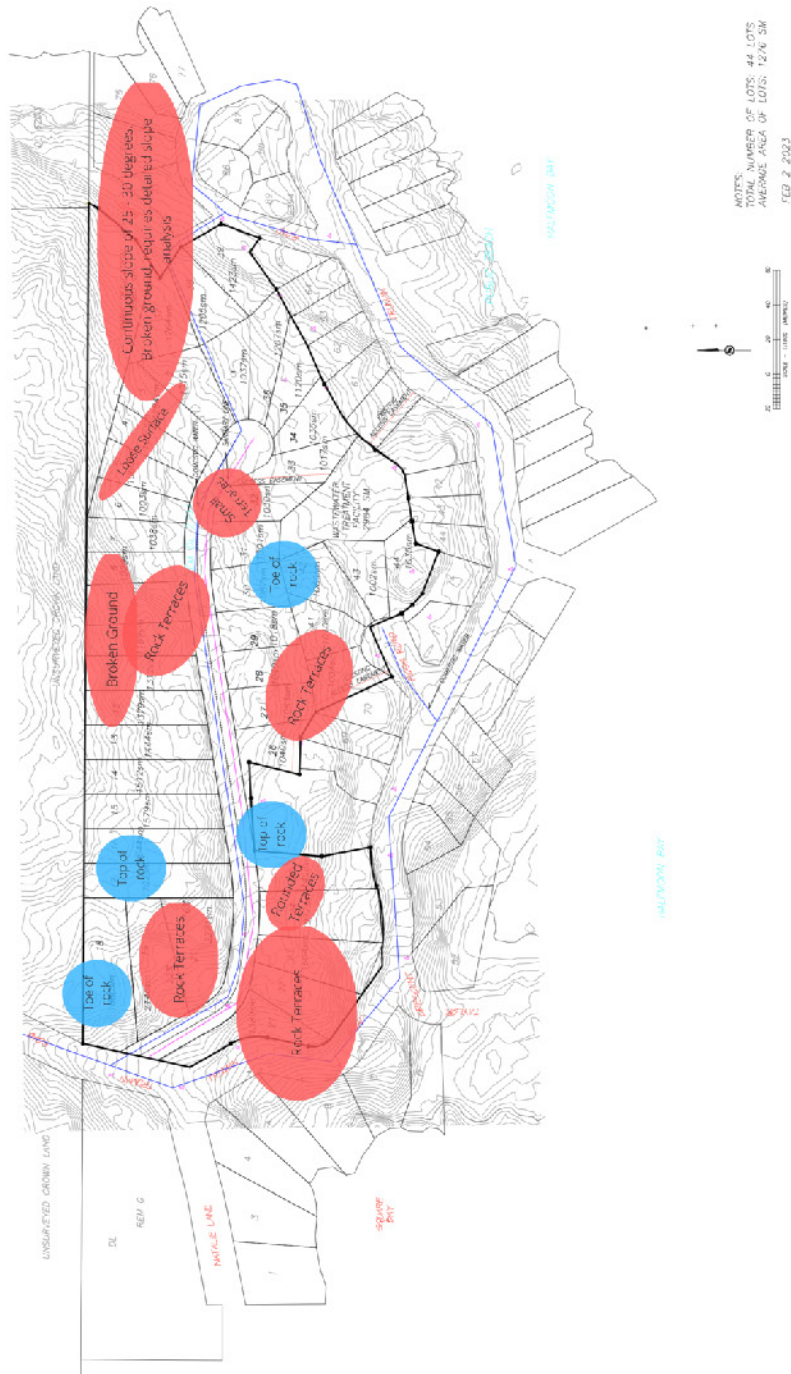
Figure 5: Enhanced version of the 1982 Golder Map, as summarized and verified by GES.

Attached herein are also two maps of all the information provided by the map included in the 1982 Golder Report, the details of which were reviewed and verified; see Figures 5 and 6.
