MEMORANDUM

FILE #/NAME: 11145/V5277

RE: Site Visit, Truman Road Feasibility Study

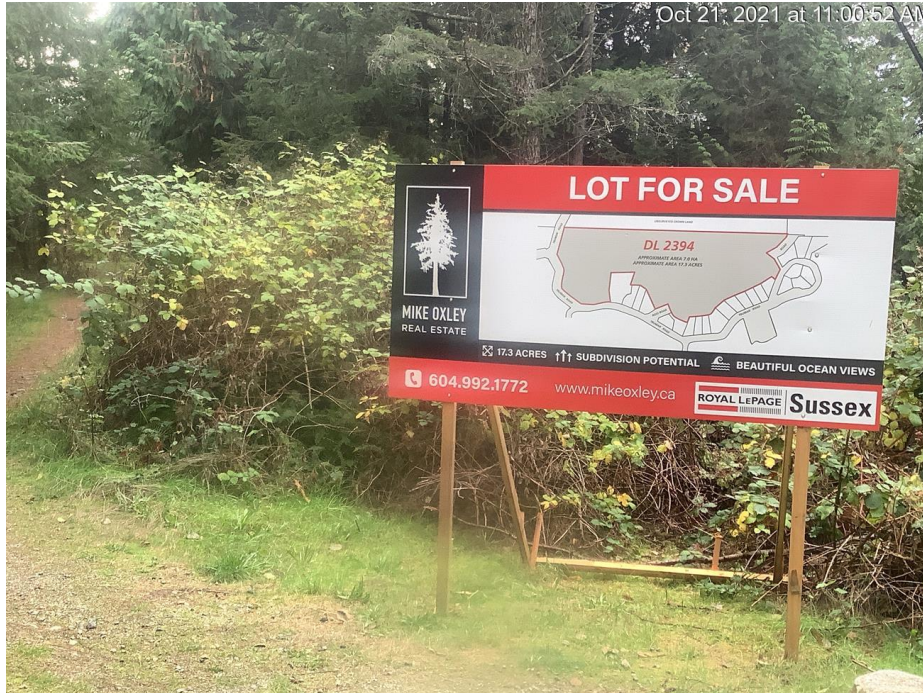
The assessment proceeded easterly from the trailhead entrance on Truman Road near Natalie Lane, landmarked by a large For Sale sign (Photo 1). This approximately 6 m-wide trail proceeds through a grove of Douglas-fir pole-sapling-sized trees that was initially cleared to become a road prior to project shutdown (Photo 2). The trail continued easterly through the length of the site and curved southwesterly down to Ross Road (Figure 1). The assessment then back-tracked in a northeastern direction, again following a clearly-demarcated wide trail to where it reconnected at the east-west corridor. Proceeding eastward from here the trail became a narrow footpath continuing to the eastern limit of the property boundary (Photo 3), then northward upslope on a foot trail marked by rock cairns (Photo 4; Figure 1). The northern portion of the path zigzagged along a lichen and moss-covered rocky terrain and open terraces (Photos 5 to 8) then turned back in a westerly direction paralleling the unfinished east-west road below. The site assessment ended by following the footpath, still marked by rock cairns (Photo 9), descending downslope to the east-west unfinished road at the western boundary of the property at the realtor's sign on Truman Road. A general outline of the transects walked on-site is shown in Figure 1.

Photo 1. Looking east into the property entrance/trail (left side of photo) at the western boundary on Truman Road near Natalie Lane

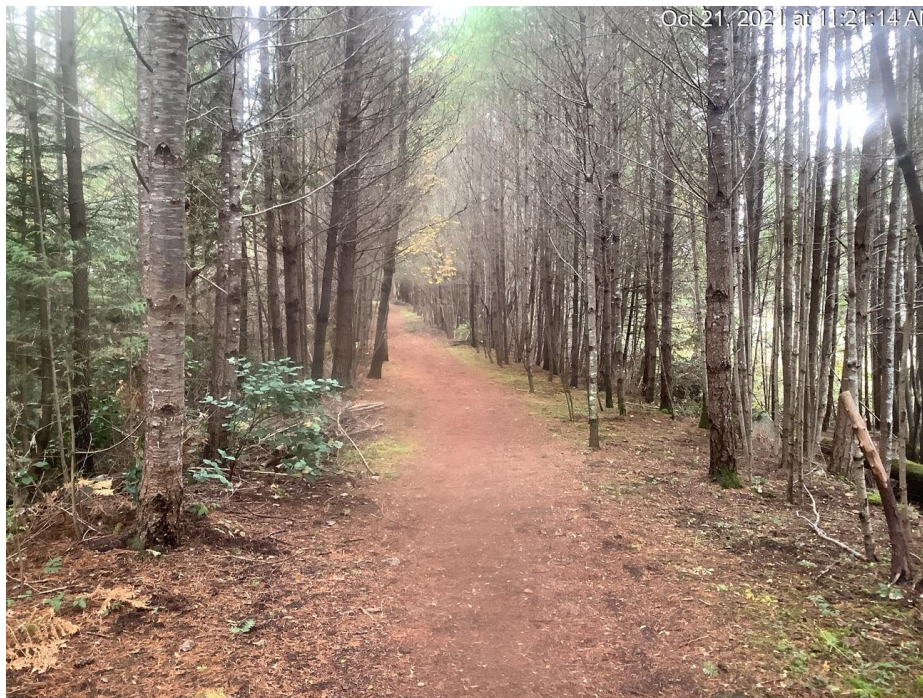
Photo 2. East-west cleared trail/unfinished road through grove of pole-sapling Douglas-fir trees

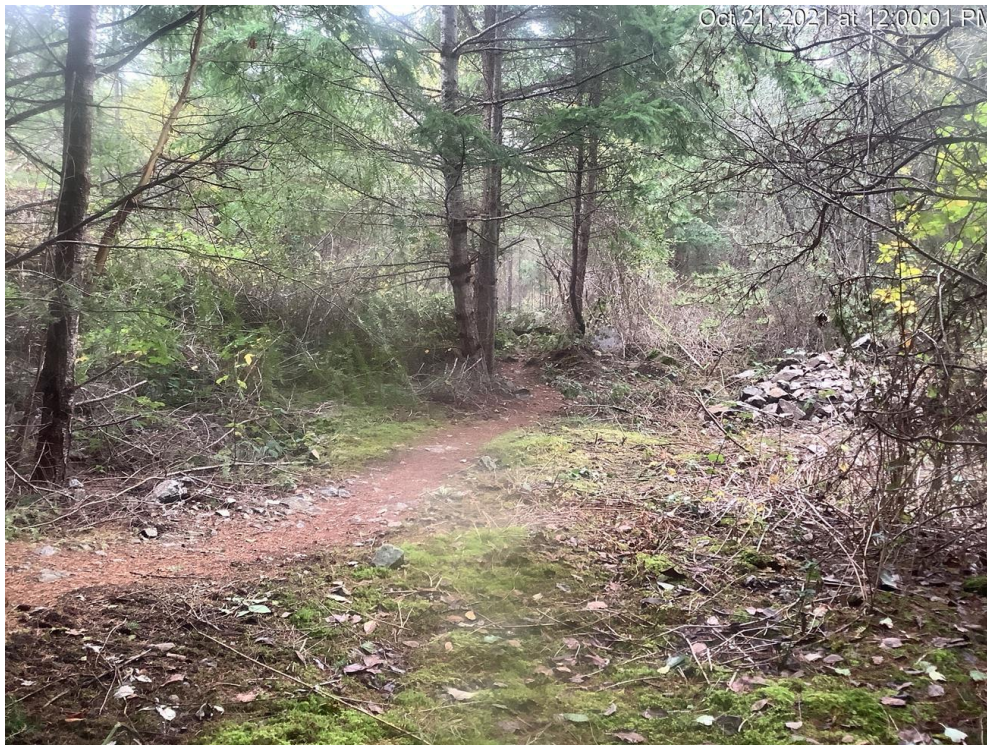
Photo 3. Eastern portion of the east-west unfinished road where trail narrows to a footpath to the eastern boundary

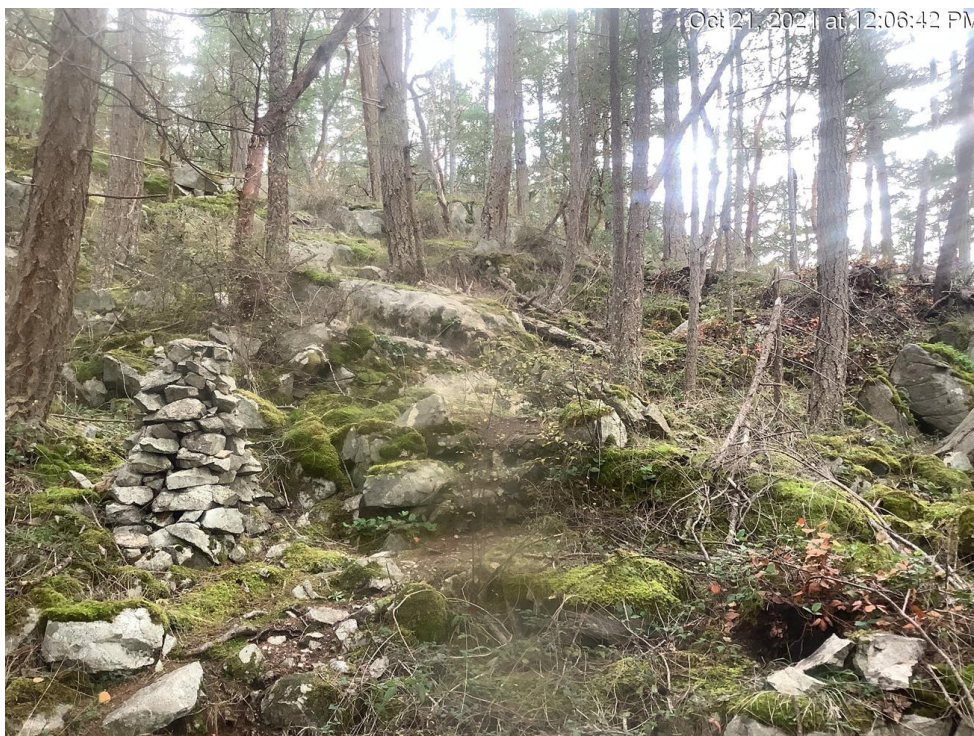
Photo 4. Foot trail marked with rock cairns (left side of photo) extending northward upslope at the eastern property boundary

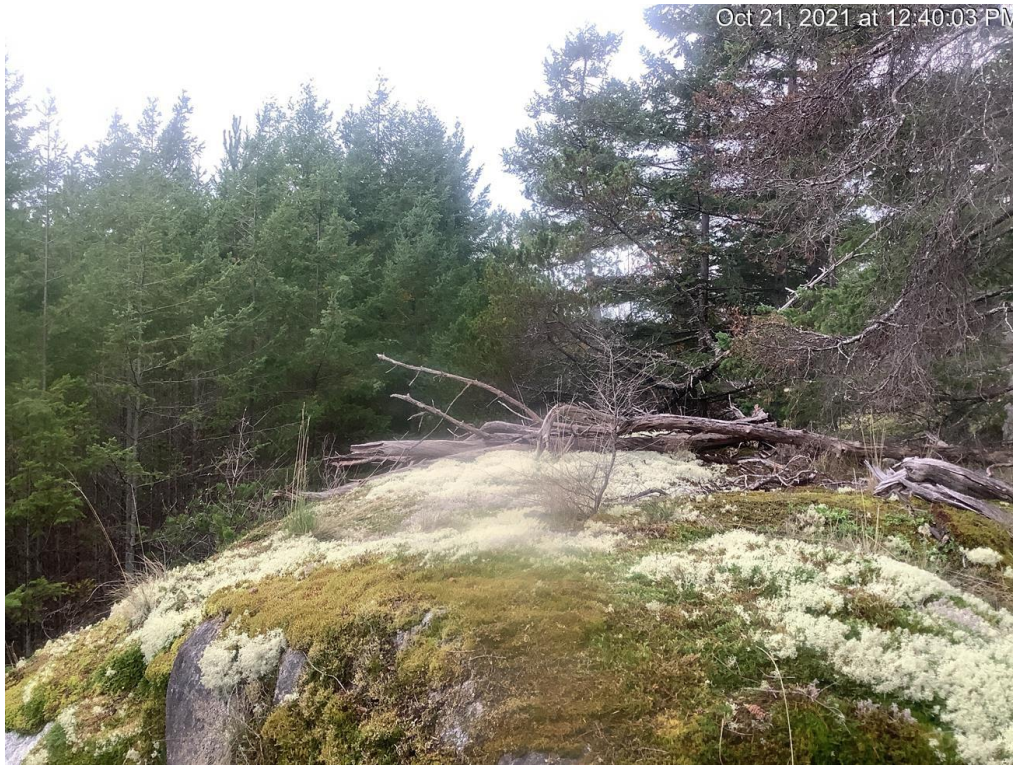
With the exception of the cleared trail/unfinished road, the majority of the property consists of steep, rocky terrain and second growth forest with open rocky terraces covered with moss and lichen dispersed throughout the property (see Photos 5 to 8). Some mature, older growth Douglas-fir (i.e., diameter at breast height >40 cm) sporadically occurs within the proposed upper lots where a foottrail skirts the upper property boundary marked by rock cairns.

Photo 5. Moss- and lichen-covered rocky terraces located throughout the property

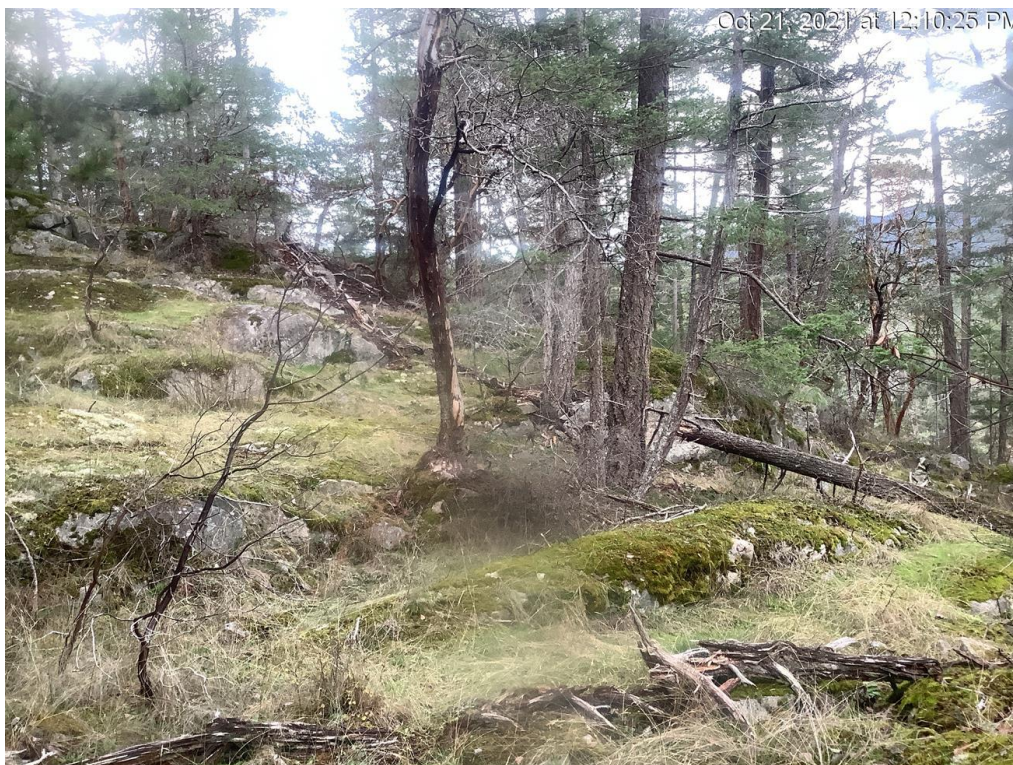
Photo 6. Open rocky terraces in upper northern portion of the property

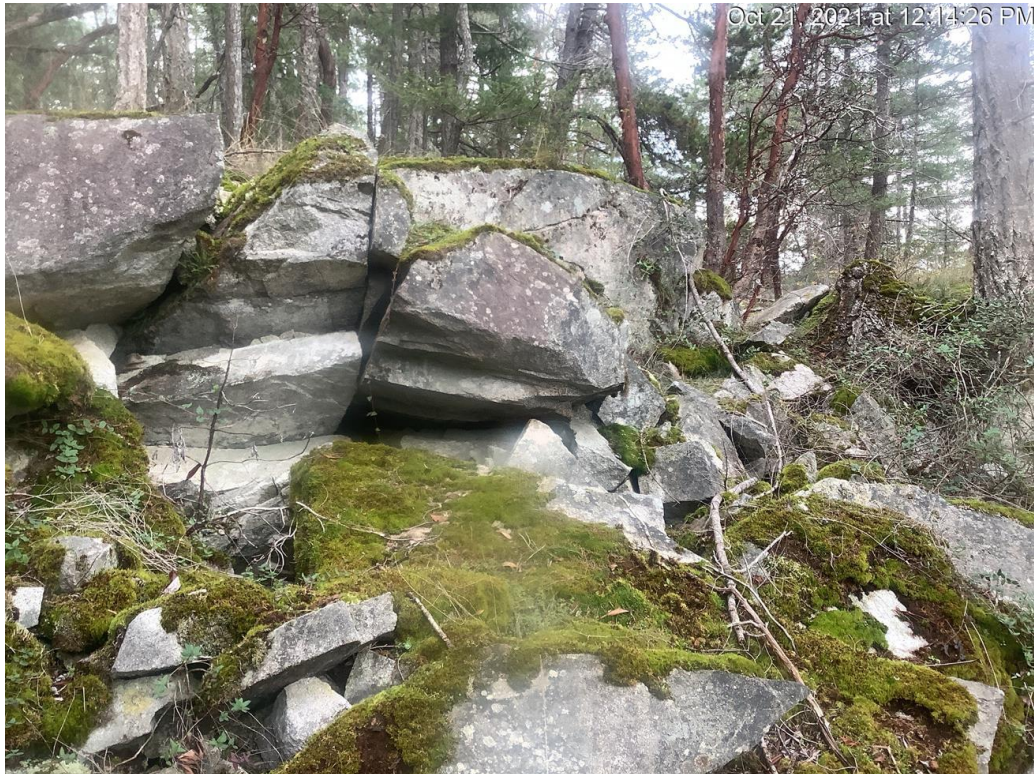
Photo 7. Moss-covered rocky outcrops in upper northern portion of the property

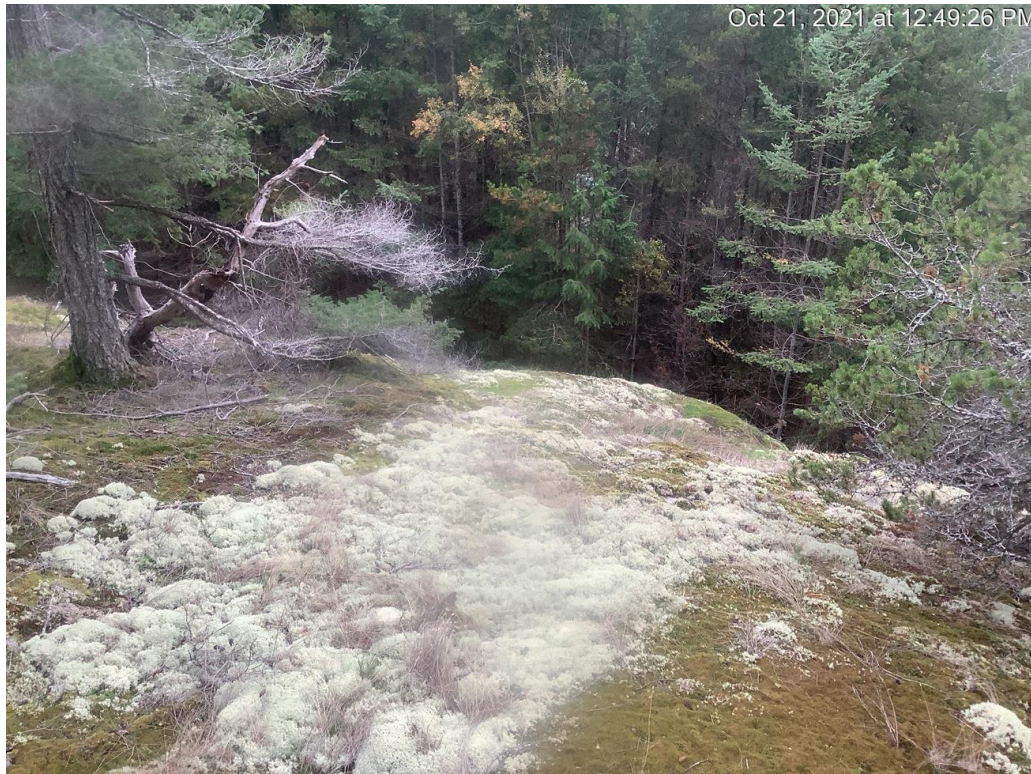
Photo 8. Lichen mat on rocky terrace located above the unfinished east-west road

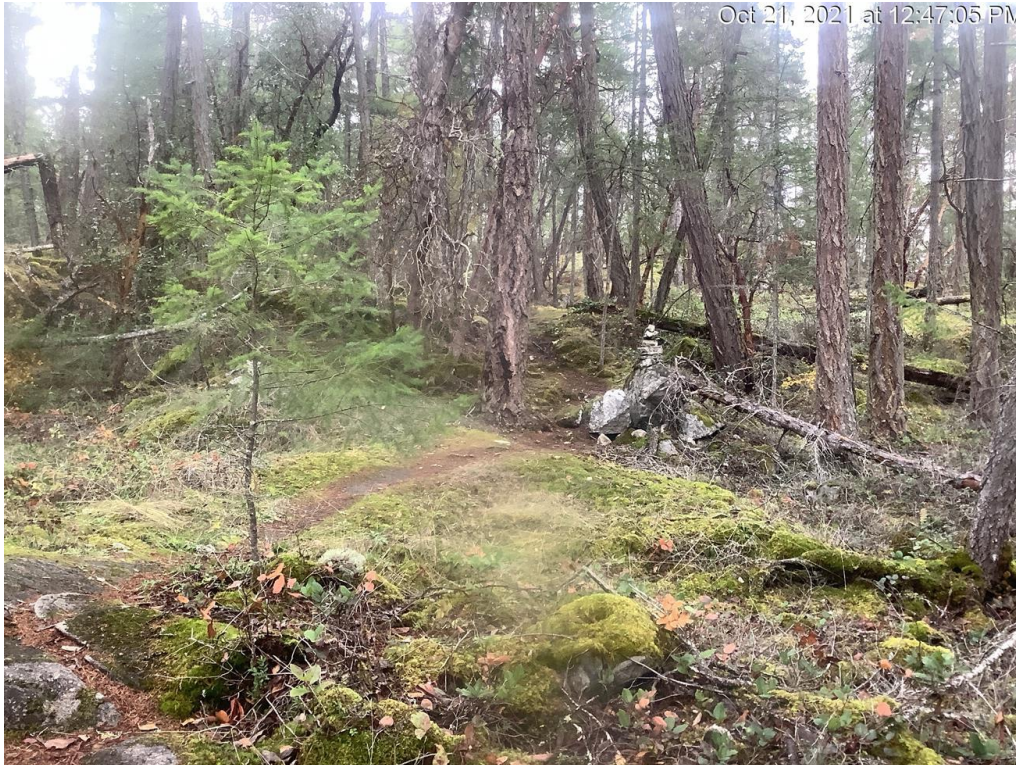
Photo 9. Foottrail marked by rock cairns descending down toward the property entrance on Truman Road along the western property boundary

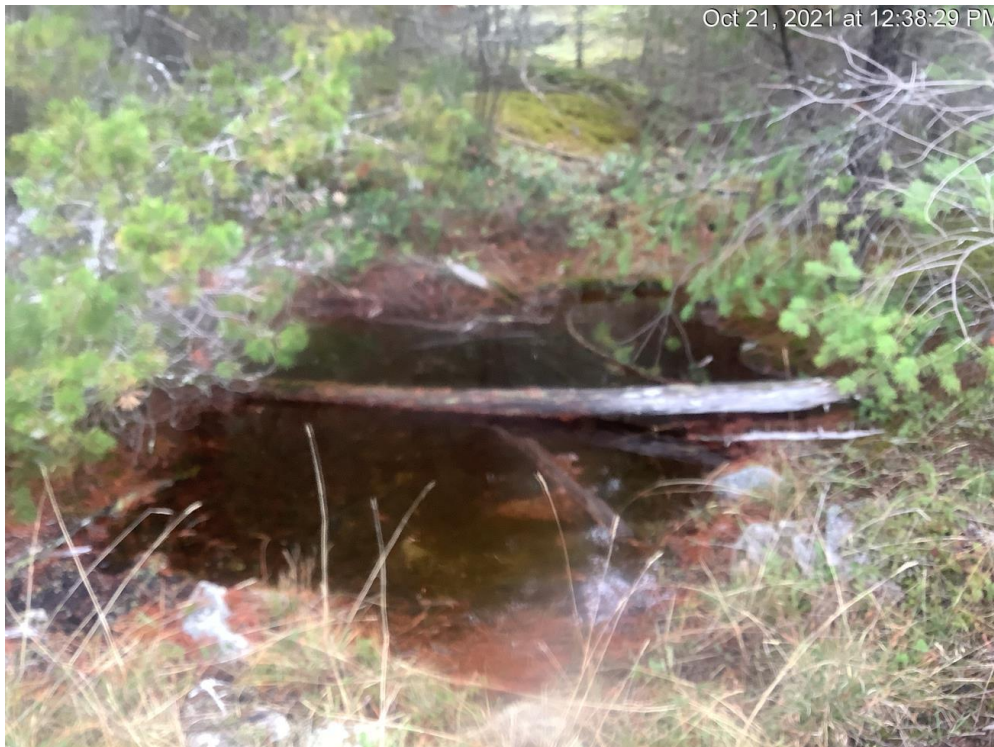
A small, ephemeral pool of standing water was observed while traversing the upper slope near the northern fringe of the lot (Photo 10; UTM 10U 432442 5484880). However, this is likely a result of pooled rainwater within a depression underlain by bedrock (thus no water permeability into the ground) as there were no wetland or riparian plants nearby to indicate long-term water presence. While it may be used for breeding by Pacific Treefrog and/or Long-toed Salamander (*Ambystoma macrodactylum*) if present in the spring, there is low risk of habitat disturbance causing mortalities at this time of year (i.e., fall/winter). No amphibians were observed here and based on the lack of any vegetation, soil, or hydrological indicators, this would not be classified as a wetland.

Photo 10. Pooled water in ground depression in northern portion of the property

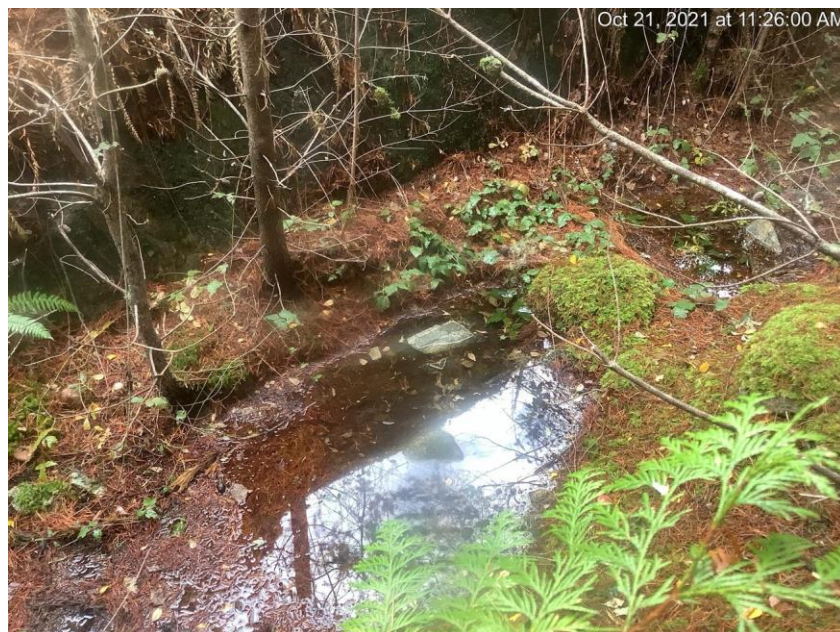
A series of ground depressions within a gully parallels the east-west unfinished road on the north side within the grove of pole-sapling Douglas-fir trees. One depression contained water (Photo 11), but the absence of any water in the remaining depressions (Photo 12) given the amount of recent rainfall indicates that water likely does not pool here long enough for any wetland species to establish (i.e., riparian-dependent plants or animals). In addition, these ground depressions did not show any channel scour, alluvium, defined banks, or any signs of erosion to indicate water flow, nor riparian vegetation.

Photo 11. Pooled water in ground depression beside unfinished road in middle of property

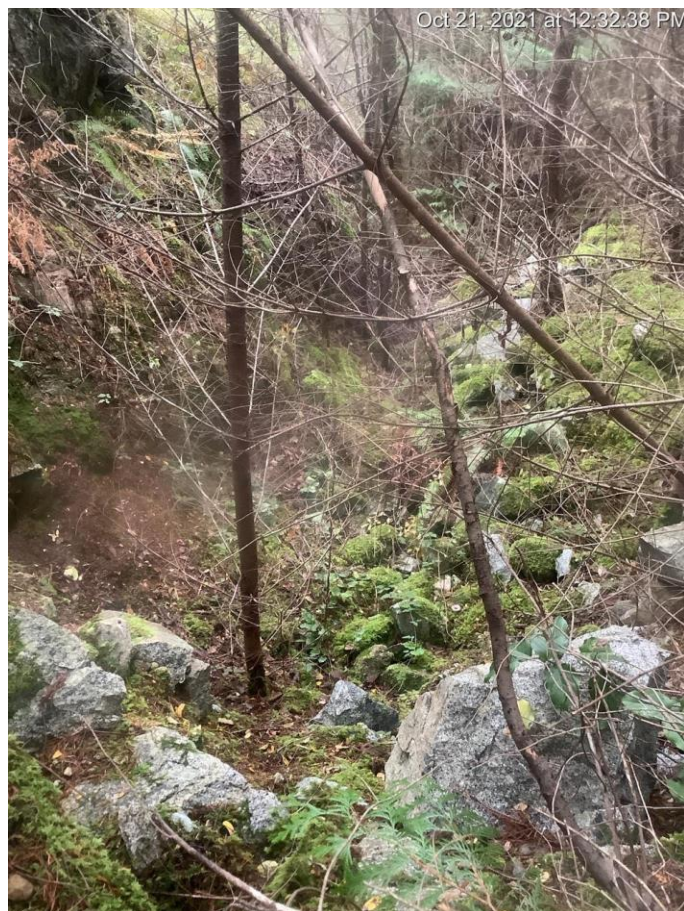
Photo 12. Dry ground depression in the gully beside unfinished road in middle of property

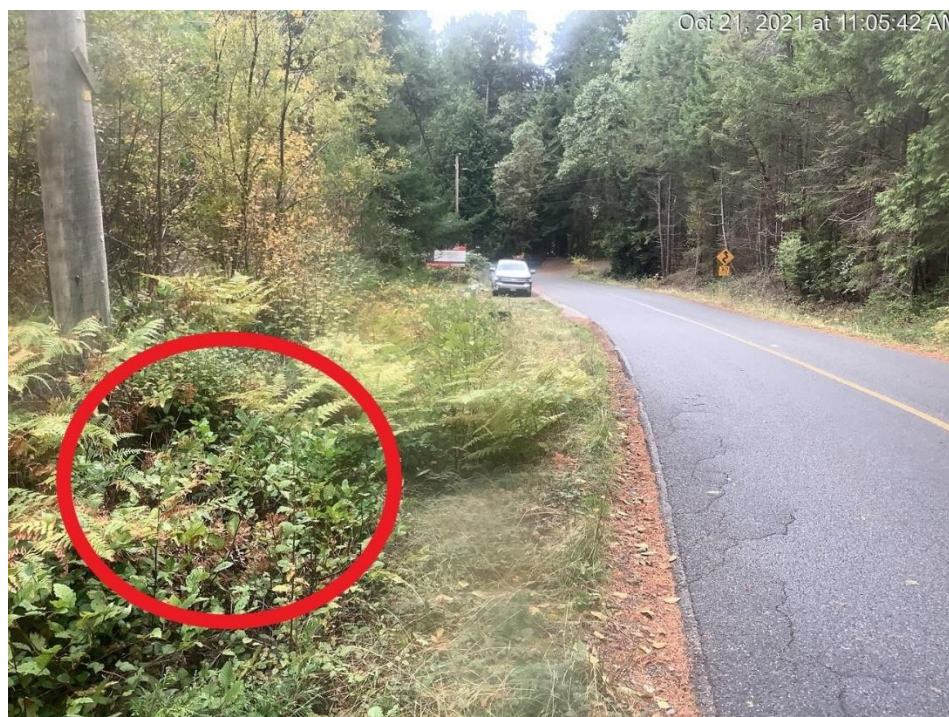
A narrow watercourse overgrown with vegetation formed by runoff from the road occurs on the east side of Truman Road north of the For Sale sign (Photos 13 and 14). Its origins appear to occur about 200 m upslope from rainfall over the bedrock and road runoff, and flows down and enters the property at the trailhead entrance by the realty sign, forming a small pool of water in this vicinity (Photo 15). However, similar to the water pool up top and the ground depressions observed further east along the unfinished road, there are no riparian indicators (i.e., vegetation) that would deem the pooled water as a wetland or as an ephemeral stream (i.e., erosion, scour, alluvium, etc.).

Photo 13. Looking south along Truman Road near the property entrance (For Sale sign to left of truck) along the western property boundary. A naturally-formed watercourse drains toward the property entrance overgrown with dense vegetation (orange circle).

The proposal to install a functional ditch along the east side of Truman Road upslope of the property entrance and a culvert under what will become the property access road, should not require any specific approvals or authorizations under the Federal *Fisheries Act*. Since this would be a non-fish-bearing watercourse due to the gradient and because it is formed by road water runoff, it will be beneficial to the local community as pointed out by neighbours, in reducing erosion rather than water running over the road as is the current situation. These considerations should be included in any development permit applications being submitted.

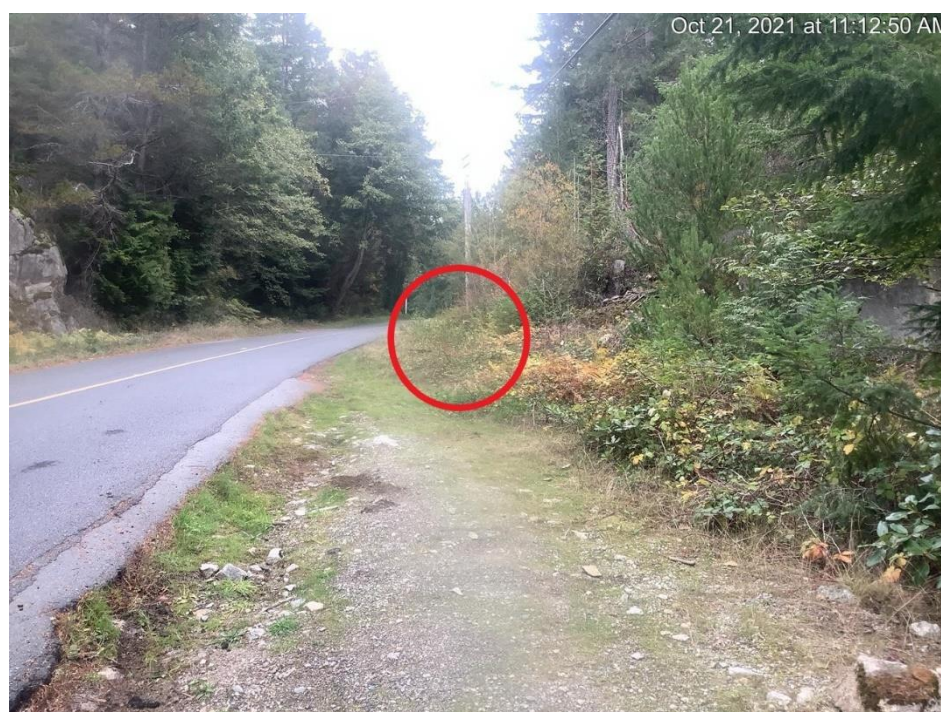
Photo 14. Looking north at the same watercourse along Truman Road overgrown with vegetation. The watercourse originates directly beside the road (orange circle) formed by runoff, then diverts away from the road and into the property near the trail entrance.

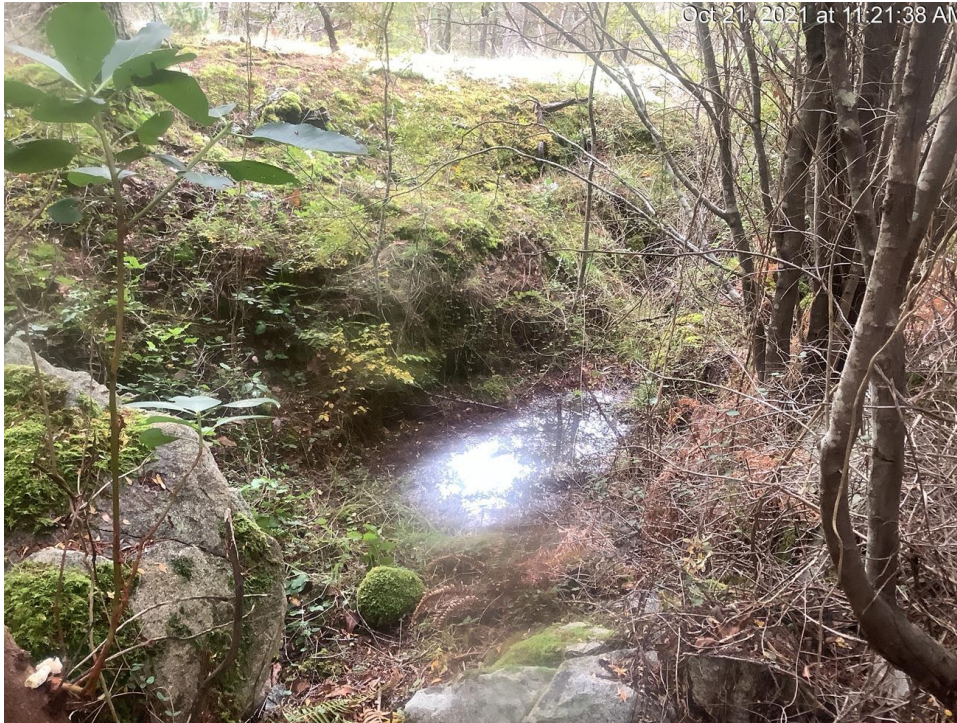
Photo 15. Water pooled in ground depression from rainwater runoff on Truman Road near the western property entrance

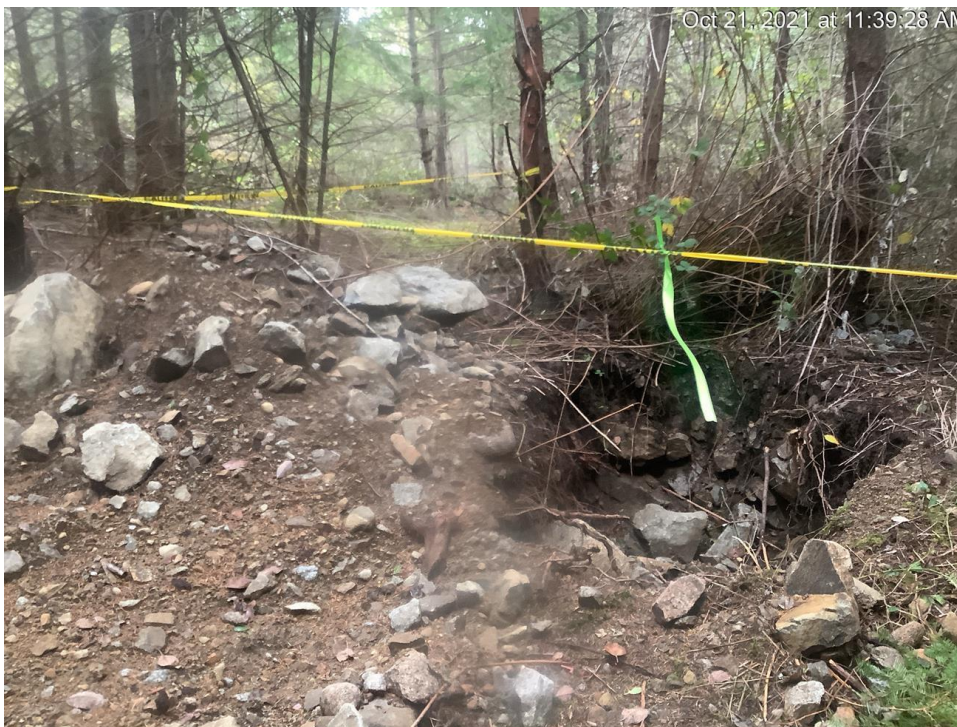
Five rectangular excavations were observed within the same 10 m² area (UTM 10U 432558 5484826; Figure 1) behind flagging (Photos 16 and 17) close to the area where the east-west trail curves southwest down to Ross Road. The source and purpose of the excavations is not known but may have been test pits dug to assess soil or substrate conditions.

Photo 16. Rectangular excavation within flagged area

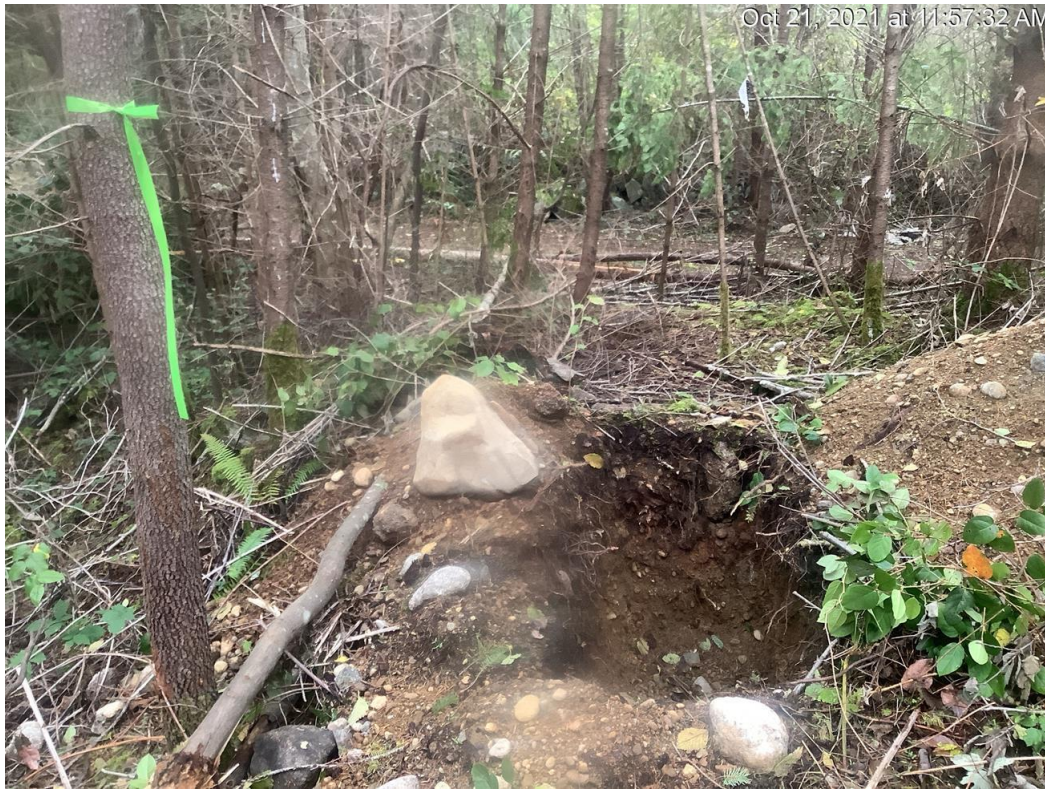
Photo 17. One of five rectangular excavations observed near the area where the main trail curves southwest toward Ross Road
