## Truman Road Development Project **Environmental Management Plan**

Halfmoon Bay Living Ltd.

**TRITON**  
Environmental Consultants

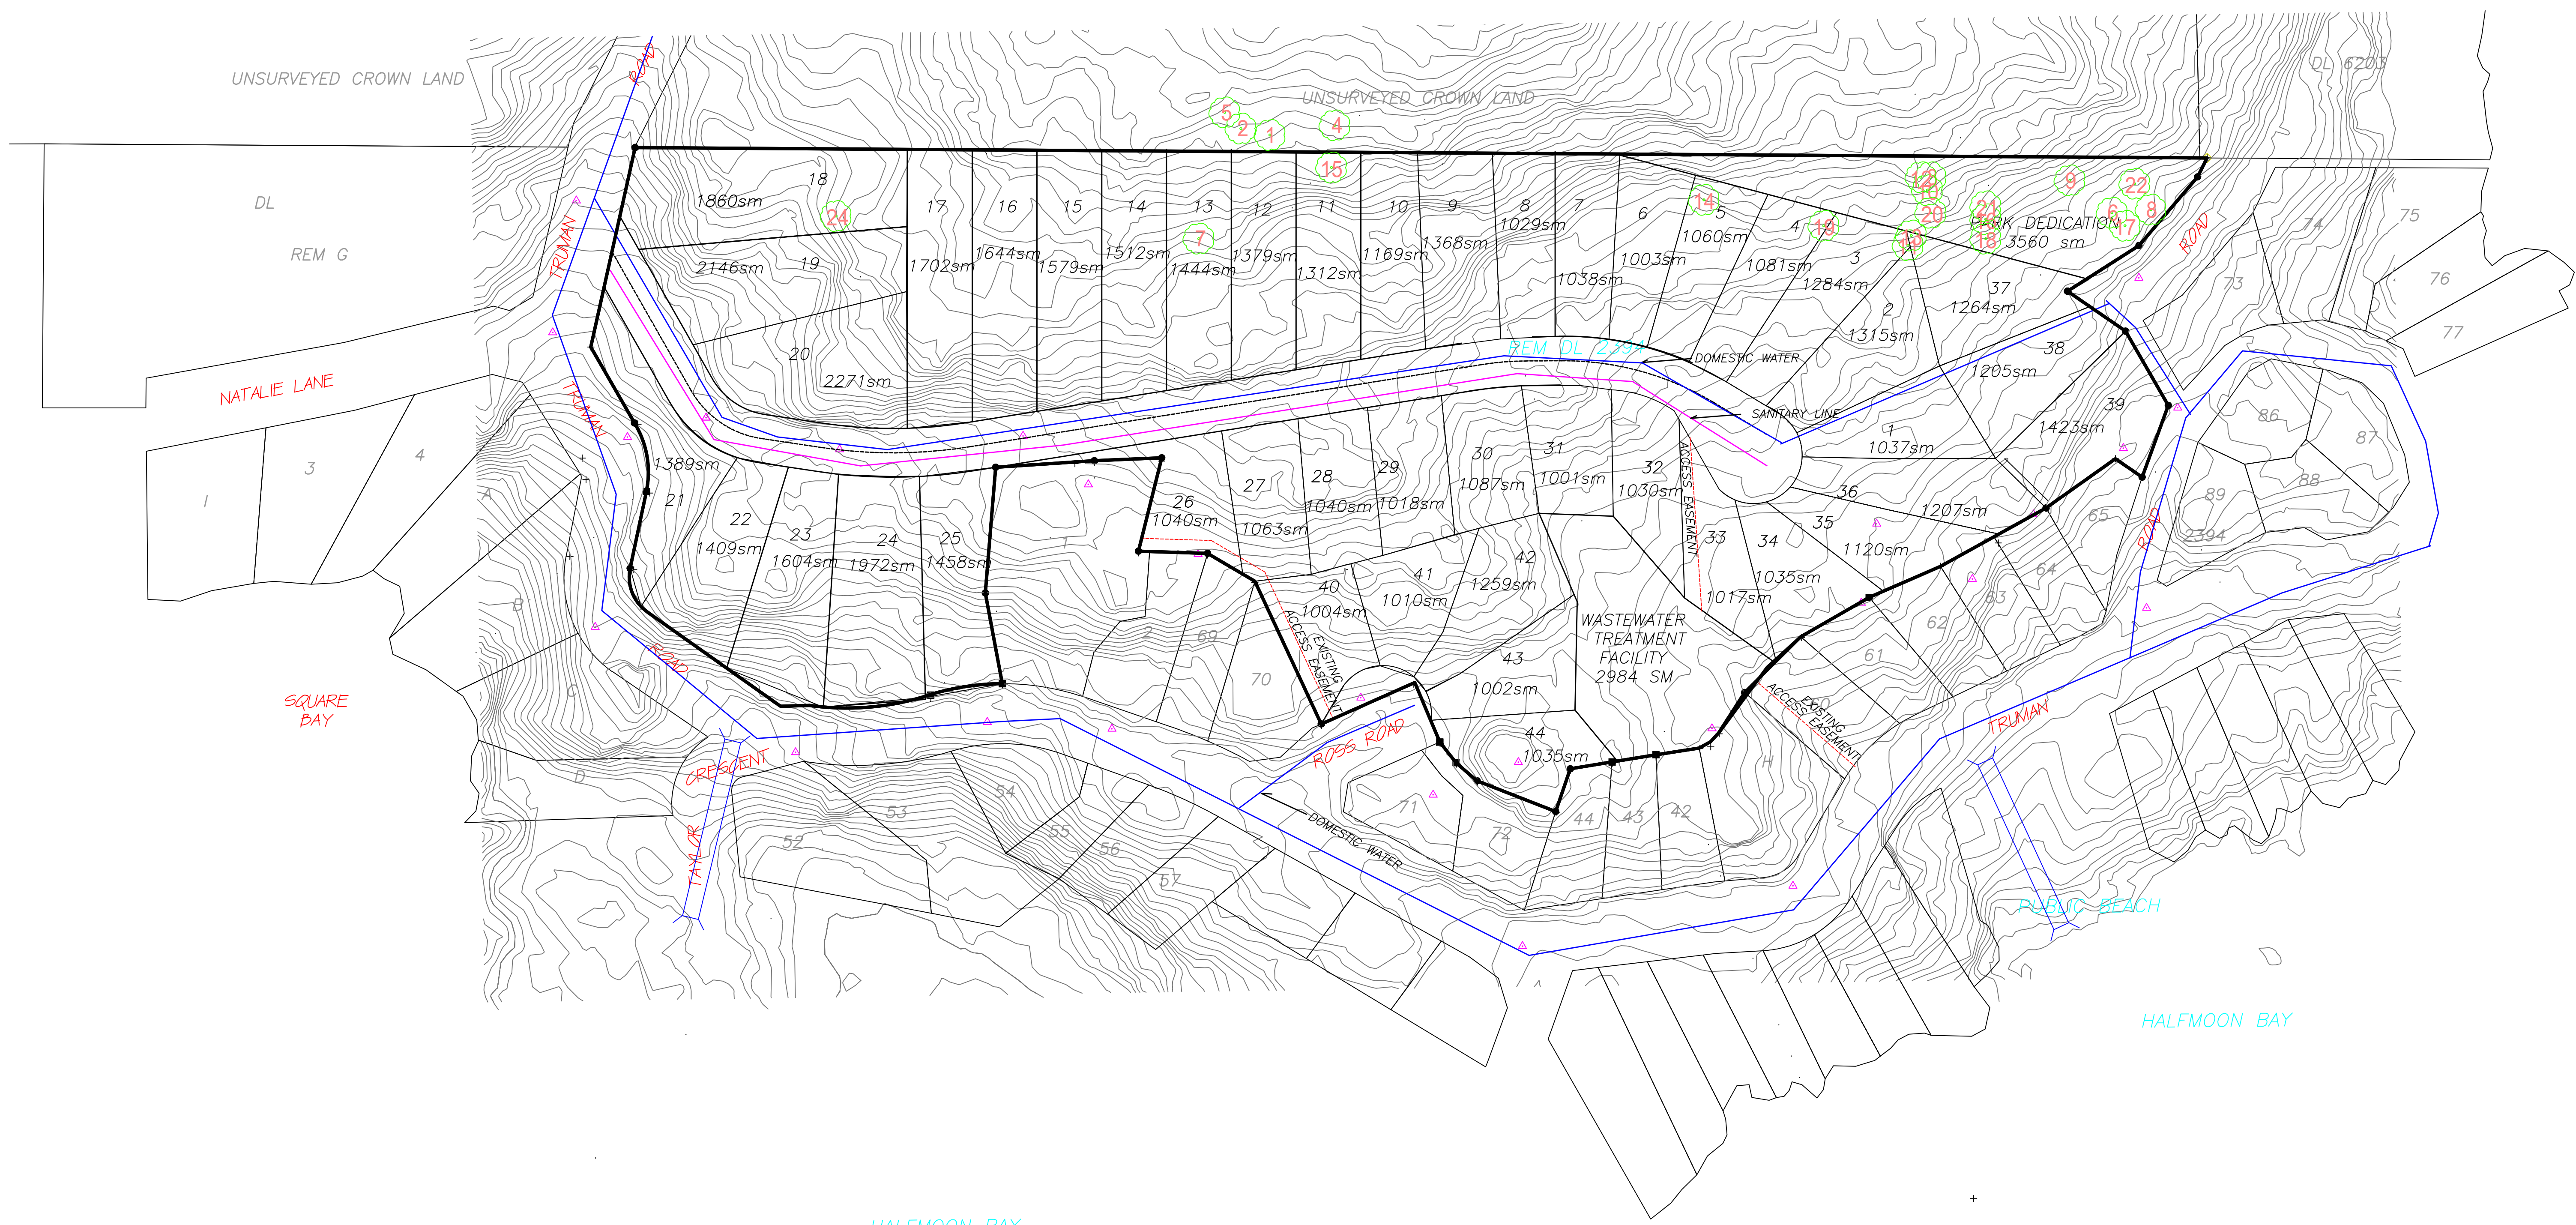
**APPENDIX 1**  
**TREE LOCATION PLAN**

A tree location plan was prepared by the Owner, noting large diameter tree locations, and is attached in Appendix 1. The Owner has indicated that only tree 24 will be removed. All other trees noted in the plan will be protected. In addition, the Owner has planned to include a 5-m protection setback zone from the north property line from lot 17 to lot 4 (west to east), and protection for the park dedication area. It is recommended that a certified arborist conduct a survey to verify that ample space has been designated for the long-term health of trees planned for protection.

The Triton Ecological Community Assessment report notes the sizes of large, older Douglas-fir trees observed near the eastern property boundary and at sporadic locations along the northern property boundary (Triton 2022).
