HALFMOON BAY LIVING LTD.

TRUMAN ROAD DEVELOPMENT PROJECT STORMWATER MANAGEMENT PLAN FINAL REPORT

Project No: 22-100
April 21, 2023
Aplin & Martin Consultants Ltd.

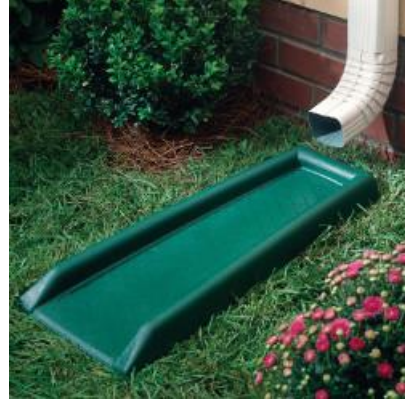
Disconnected Roof Leader

- Onsite Source Control Measures:
 - Where the site is proposed for minimum 50% of pervious area covers, a minimum depth of 300mm amended topsoil is recommended to be placed in the proposed lawn/ vegetation areas. The amended topsoil is essential to support vegetation growth, while it can also be used as a stormwater source control feature to allow absorbance of the rainwater and surface runoff into this soil layer, prior to seeping into the subsurface native soils and/or rocks.
 - Roof leaders shall be disconnected to drain to the lawn/vegetation areas with amended soil cover, or to the native ground.
 - All impervious surfaces (e.g. driveways) shall be sloped to drain to the lawn/vegetation covers or native ground.

The above proposed onsite source control measures are to promote the subsurface drainage as that occurs under the existing onsite drainage conditions. To avoid potential flooding due to the runoff from the upstream north hillside area in Crown land, rock pit on the rear side of the northern properties shall also be installed to intercept and infiltrate the surface runoff, if any, from the hillside area. Interceptor drainage system is to be applied around the building to safely convey the excessive runoff under large storm events. It is recommended that residential buildings to be built shall not have basement and foundation drainage system to avoid any interception to the groundwater flows to increase the runoff flow rates via the proposed drainage conveyance system.

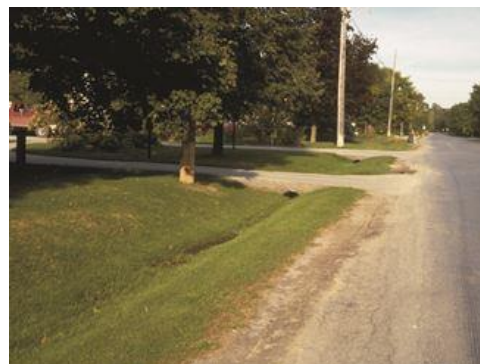
Roadway Stormwater Management Concept

- Offsite Roadway Source Control Measures:
 - Road drainage shall be collected and conveyed via the roadside ditch which bioswale can be incorporated with rock drainage at the bottom to promote infiltration to the native ground while conveying the flows downstream directly.
 - The proposed downstream new storm sewers along the Taylor Crescent shall pick up flow from the upstream bioswales and convey it to the ocean to prevent flooding in the private properties.

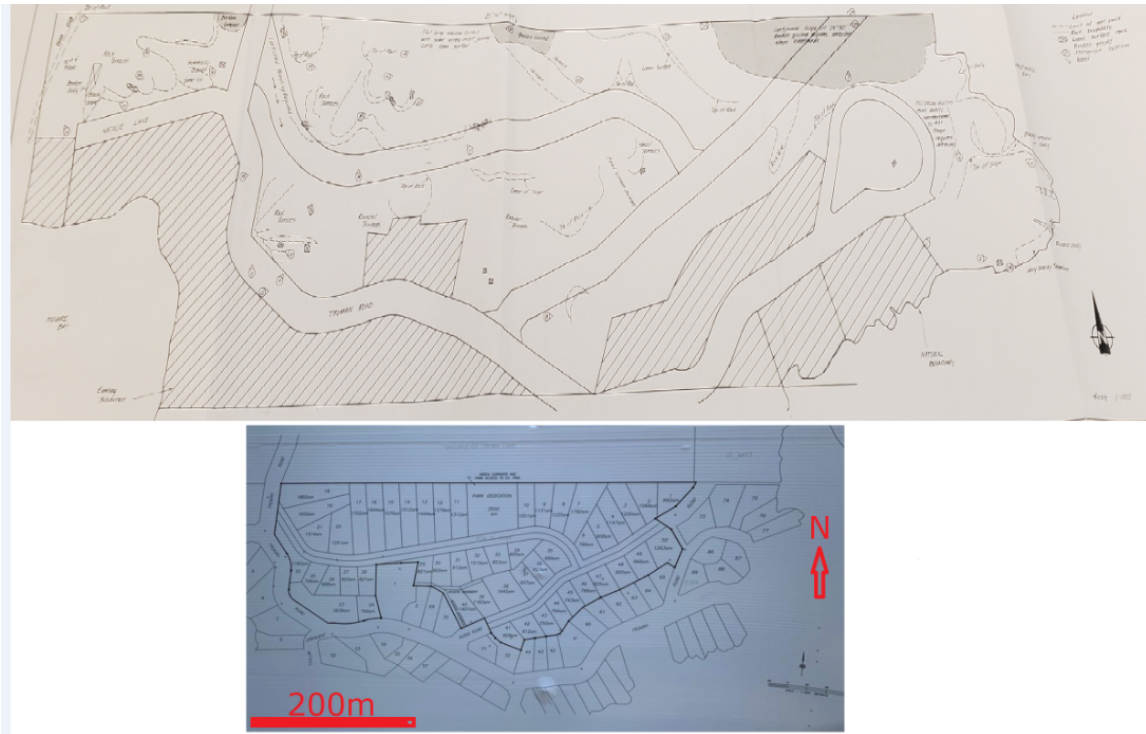
Figure 2: Subject Property's Layout

The subject property is being proposed by the Client as a 50-lot subdivision, subject to the approval of the Sunshine Coast Regional District (SCRD). The areas located along the south, east and west boundaries of the property have already been developed. For the general layout of the subject site, see Figure 2.

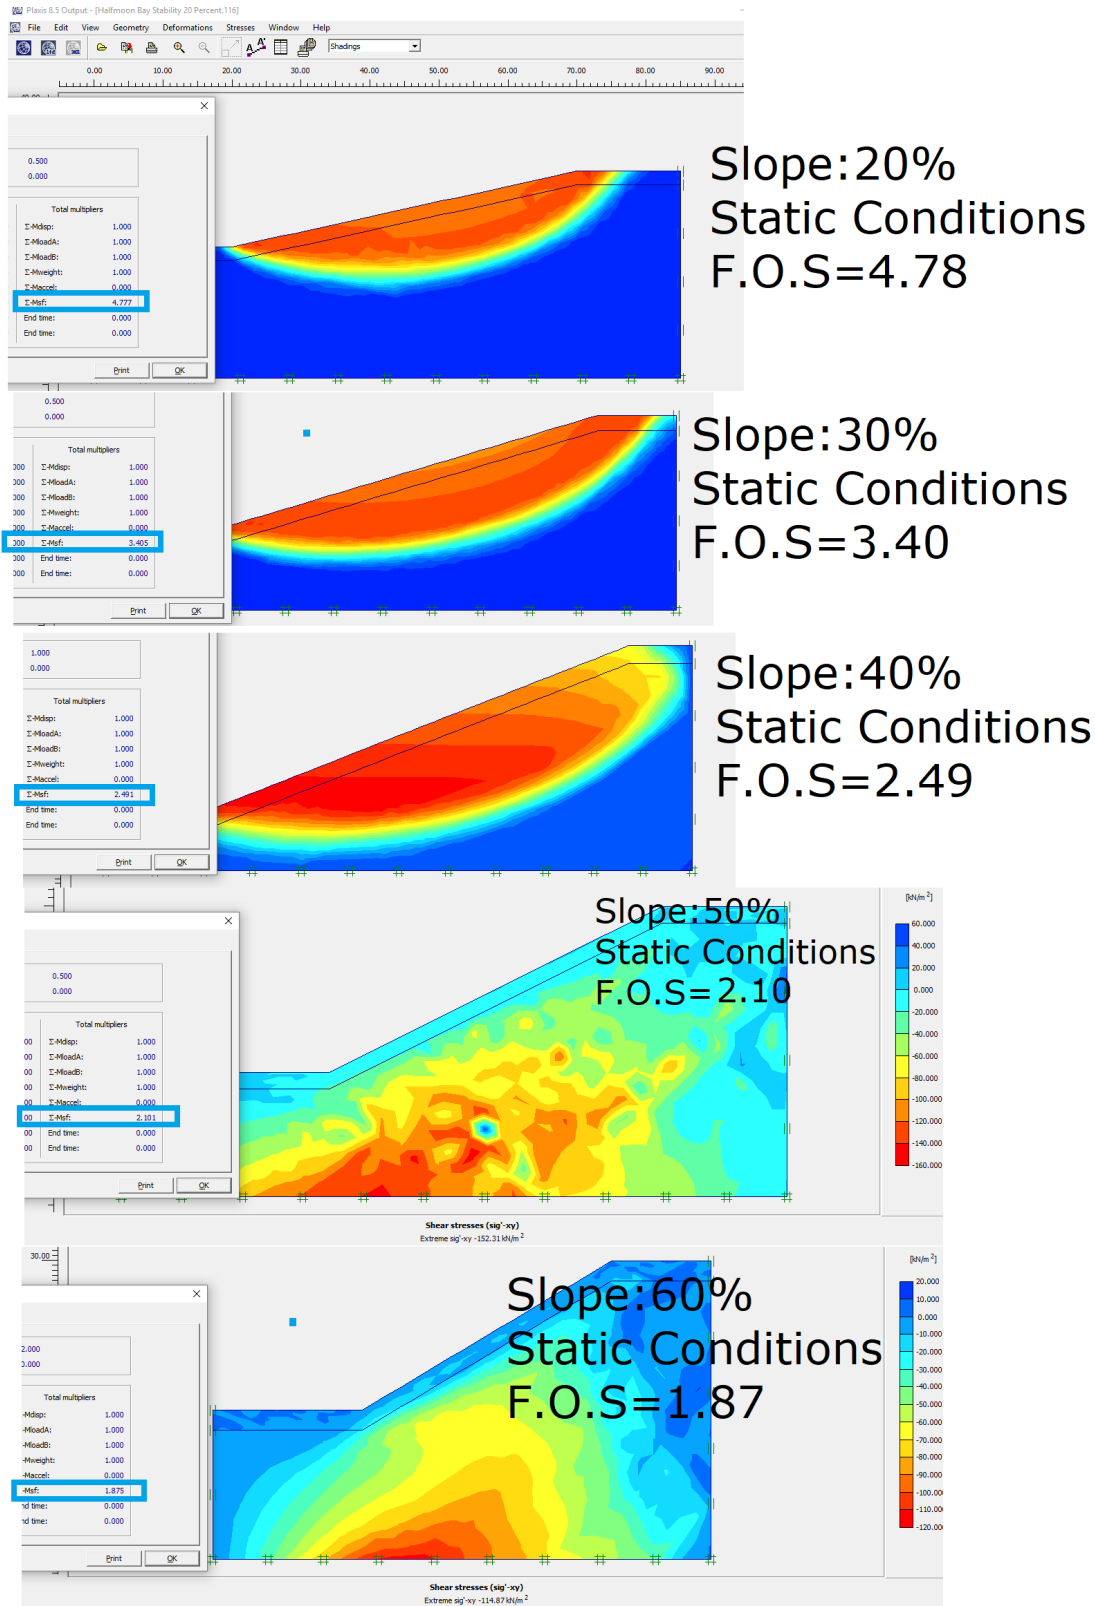
Figure 8: Slope Stability Analysis Results under Static Conditions for Different Slope Gradients

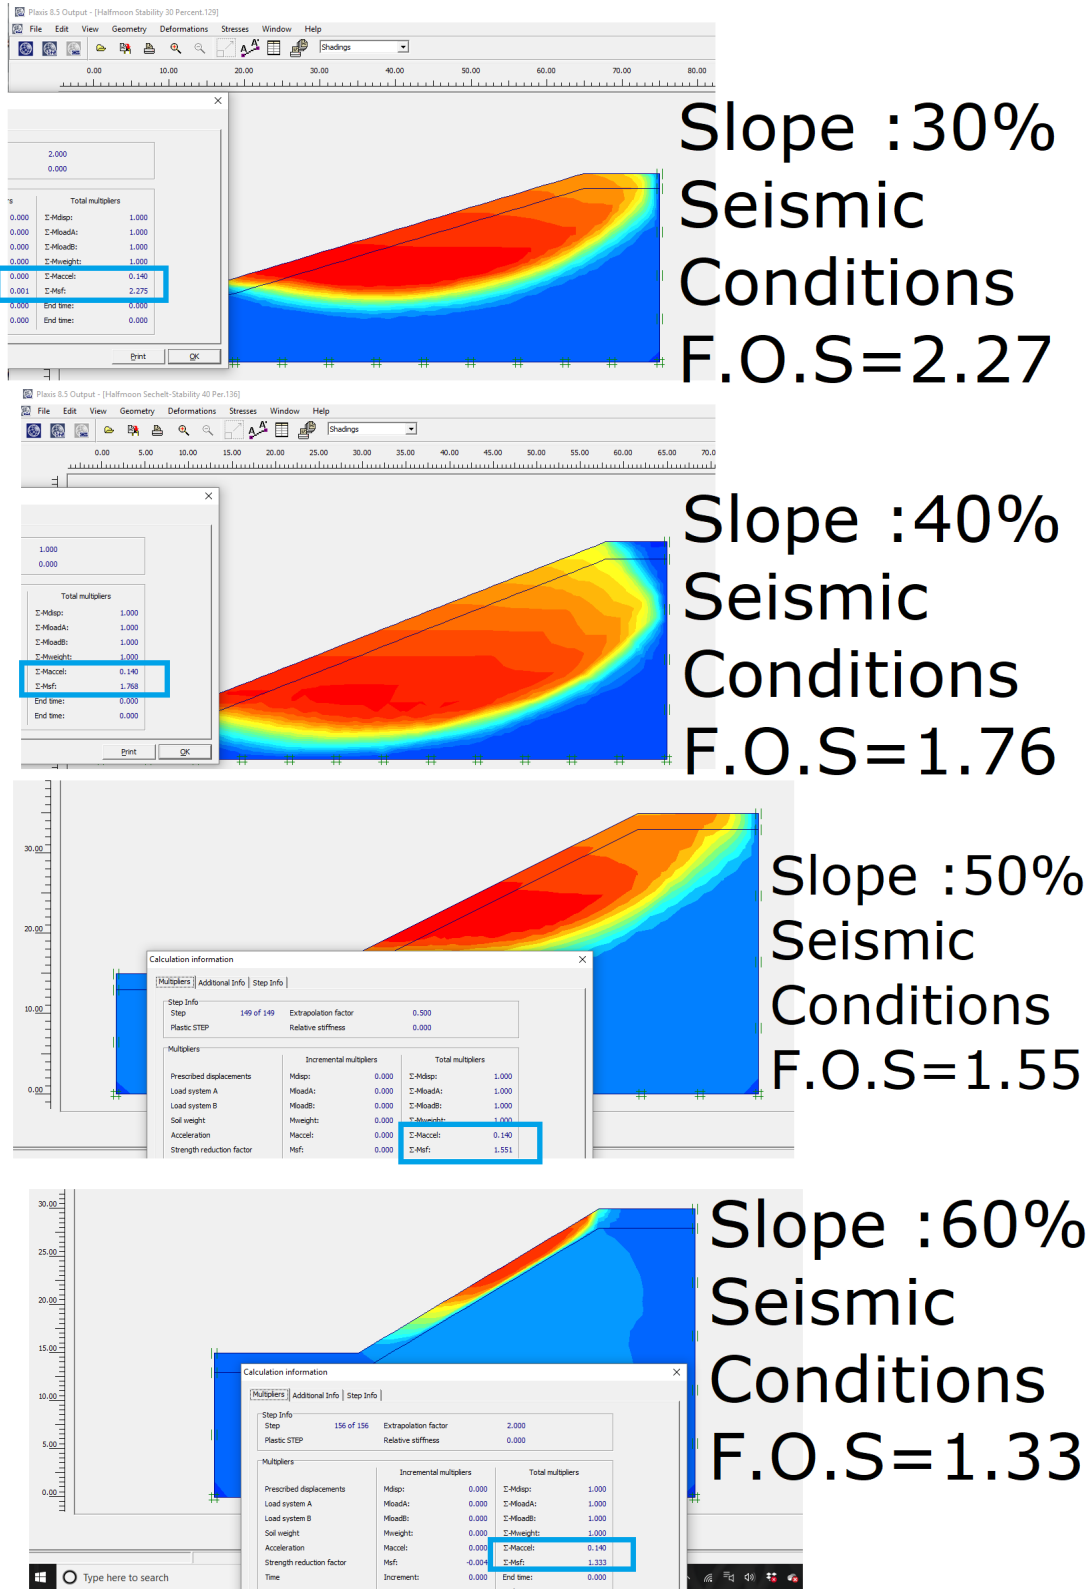
Figure 9: Slope Stability Analysis Results under Seismic Conditions for Different Slope Gradients

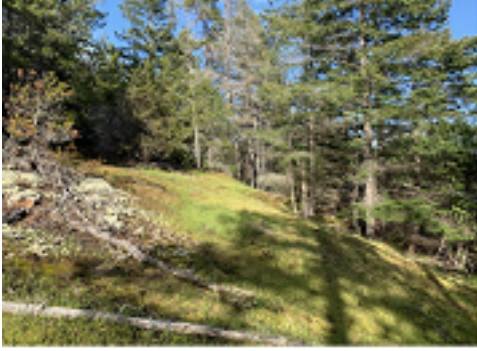
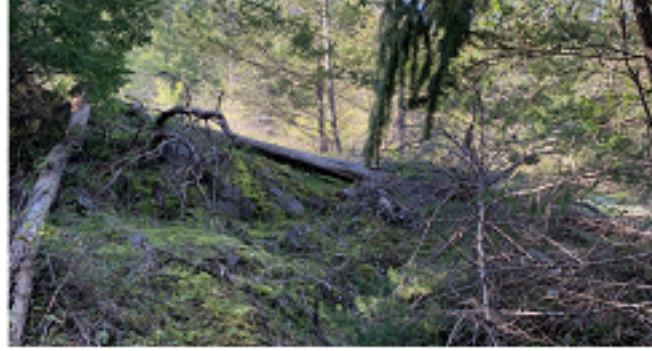
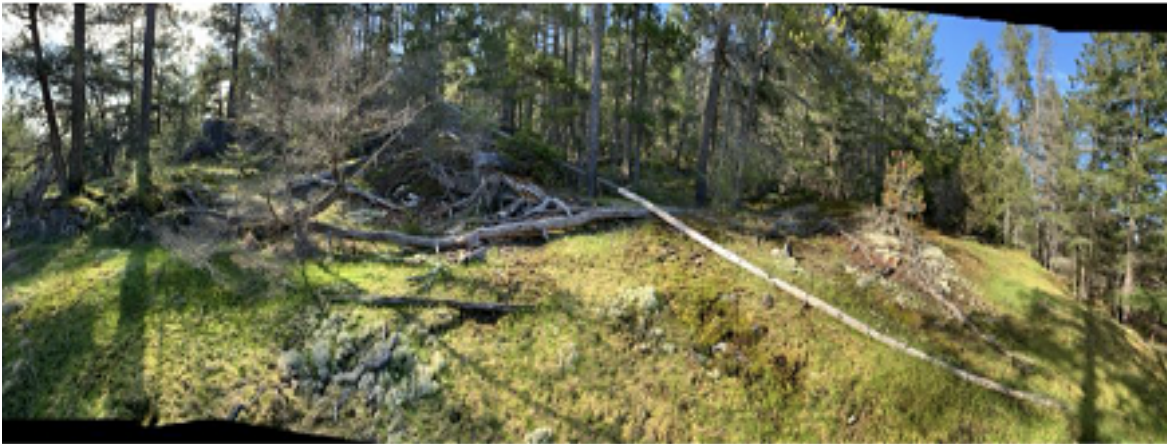
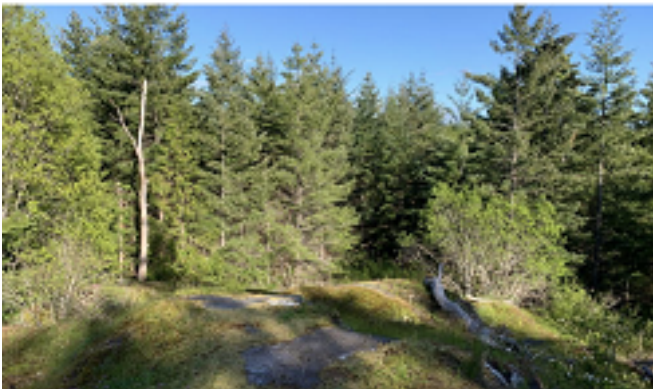
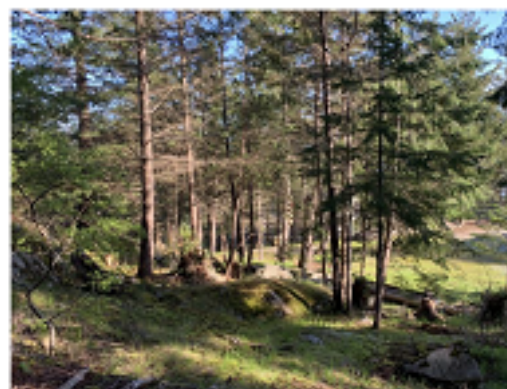
Photo 1: Massive Intact Granitic Rock Zone ("Zone 1")

Massive, intact, granitic rocks cover more than 60% of the subject property with a little soil or rock cover. From a geomorphological point of view, the massive intact zone corresponds to the rounded or terraced areas, having smooth surfaces. The slopes in this zone mostly have about 15%-25% grade. However, in some locations there are steeper slopes, up to about 50% or more. In our professional opinion, this zone is developable area with conventional engineering approaches regarding foundations and other geotechnical aspects. For the general conditions of Zone 1, see Photo 1.

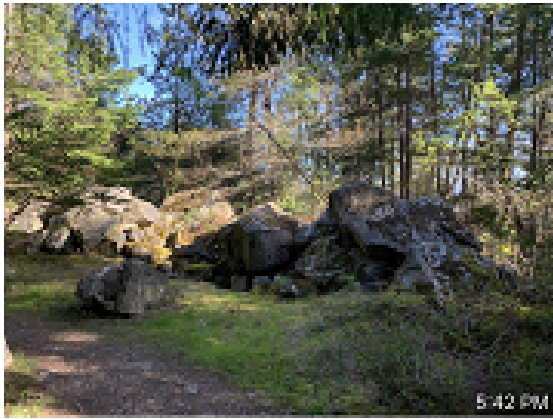
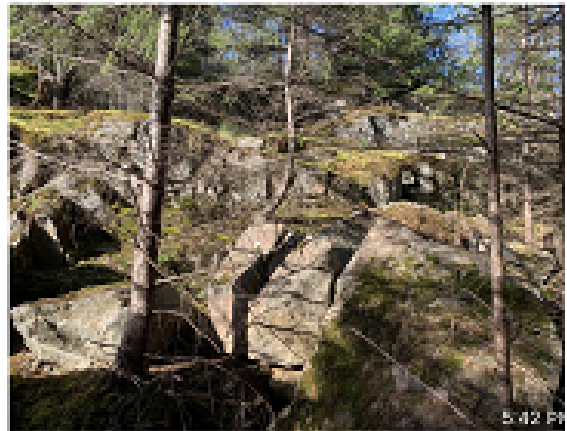
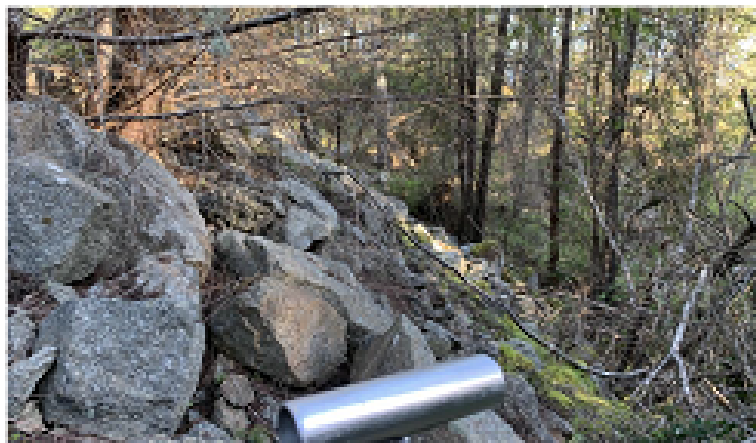
Photo 2: Loose Surface Rock Blocks Zone ("Zone 2")

along gullies and also at the foot of some slopes. The slopes' grade in this zone are generally greater than about 20%. In some locations, the slopes are steeper, reaching up to about 40%-60% in this zone. In our professional opinion, this zone is mostly undevelopable, unless measures are taken including the removal of most of the loose rock blocks, and setting the foundations on very stable large rock blocks or on lower intact rocks. For the general conditions of Zone 2, see Photo 2.

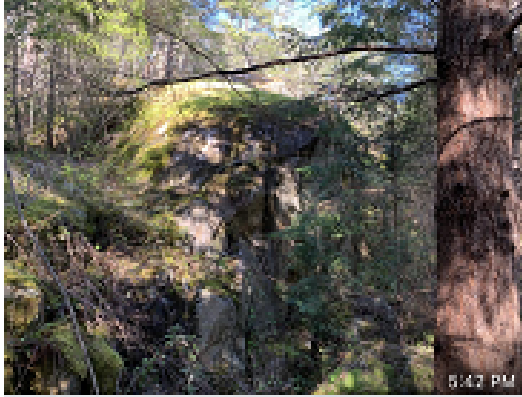
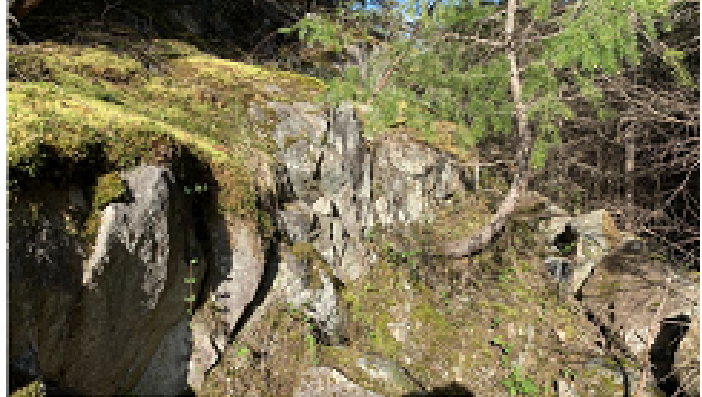
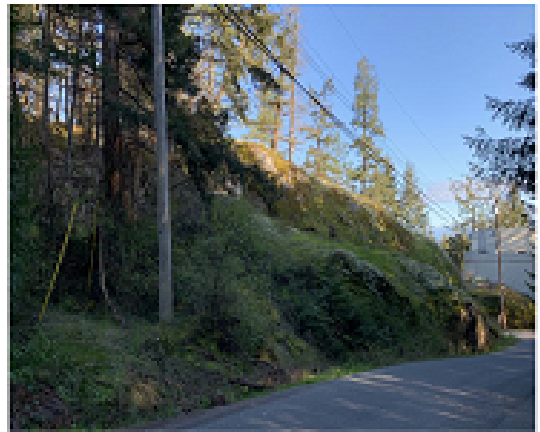
Photo 3: Broken Rock Zone ("Zone 3")

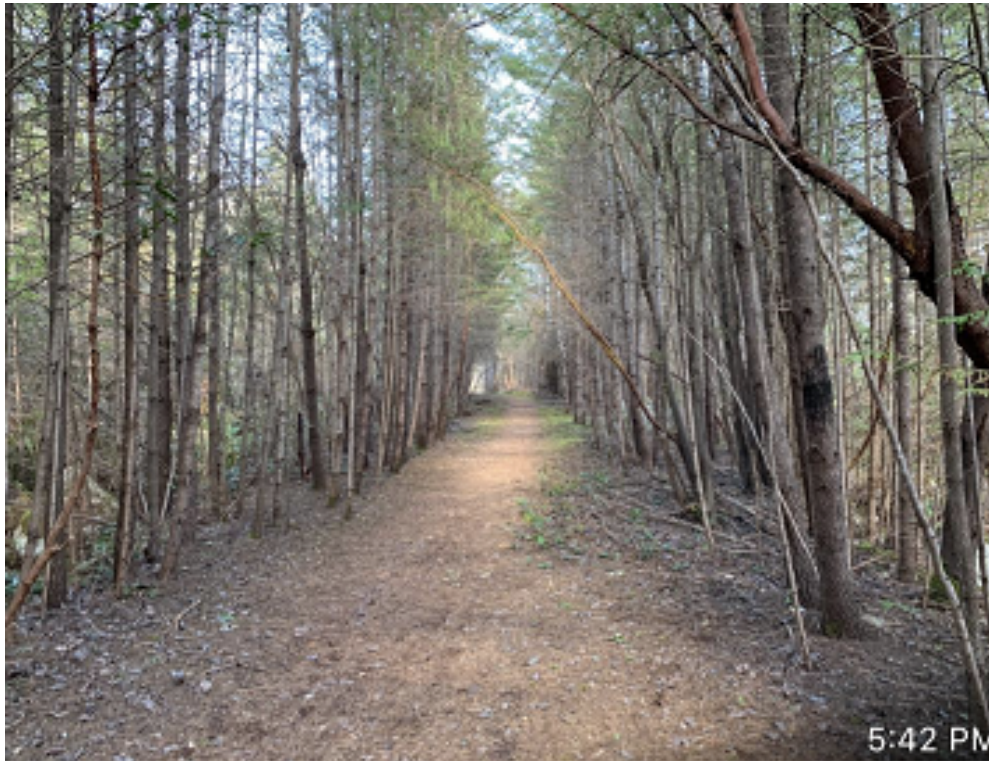
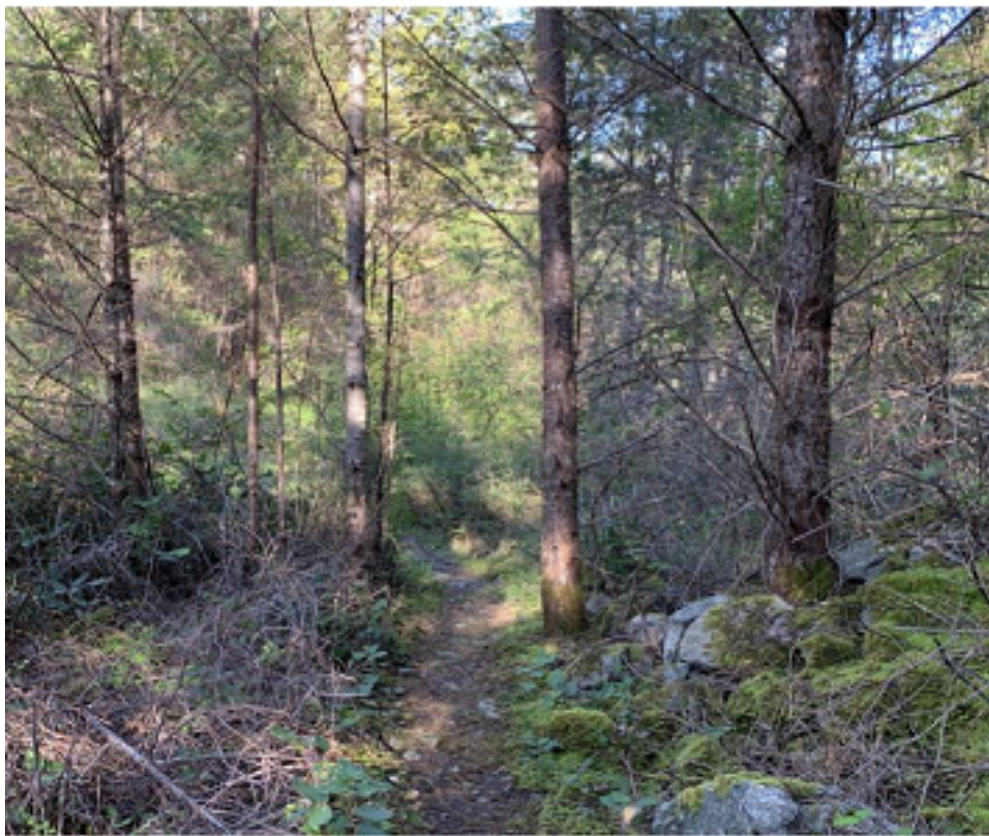
Photo 4: Smooth Surface Terraced Zone ("Zone 4")

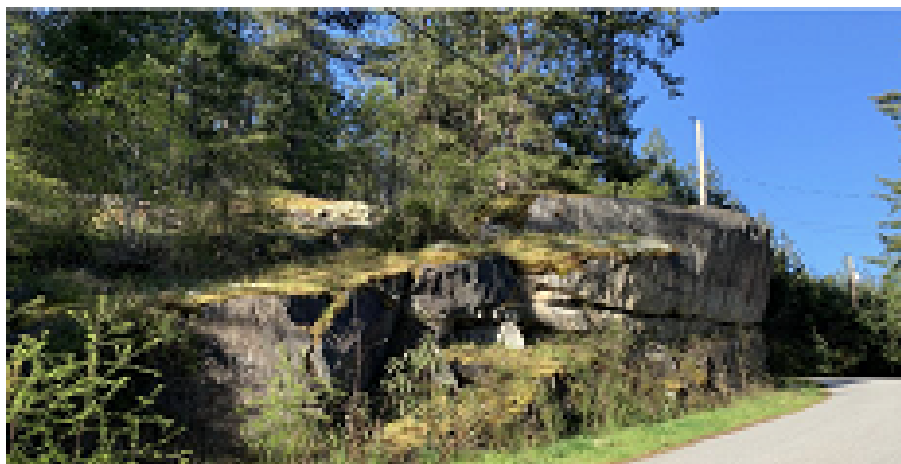
Photo 5: Rock Scarps Zone with Sliding Potential ("Zone 5")

The fifth geotechnical feature of the subject property is rock scarps some with sliding potential. The weight of some rocks in this zone may reach up to 10 tonnes or more. We estimate that this geotechnical feature covers a maximum of about 5% of the land surface. From a geomorphological point of view, the rock scarps with sliding potential are mostly at the crest of some slopes. The slopes' angle in this zone may reach over 60%. In our professional opinion, this zone is generally undevelopable land, unless there is the removal of the large sliding rock masses or the application of extensive geotechnical mitigation measures such as elaborate rock nailing, anchors and heavy grouting, or similar mitigation techniques which will have to be developed at a later date, in the event that the approved subdivision development includes Zone 5 areas. For the general conditions of Zone 5, see Photo 5.

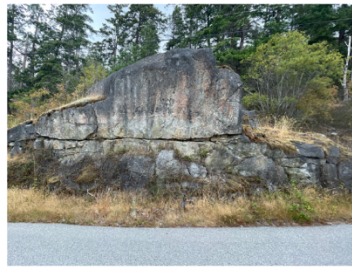
1 Rock terraces

3 Rock scarps. Evidence of significant potential for a future rock slide. Joints present (Marked pink on the previous plan provided by GES, June 24, 2022)

Figure 1: Map of the subject site, focused on Truman Rd.
Overlay done by GES.

We started our August 3 site visit by carrying out a walkover survey along Ross Road; see Figure 2. Once we reached the end of the subject property line, we hiked up to investigate the upper lots; see Figure 3. After that, we went over the lots along Truman Road; see Figure 1. Figure 4 shows the information included in Figures 1, 2 and 3, thus easing reference to all the pertinent geotechnical information collected and summarised from our August 3 detailed site reconnaissance.

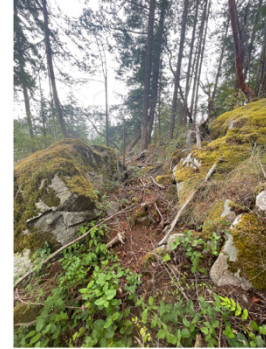
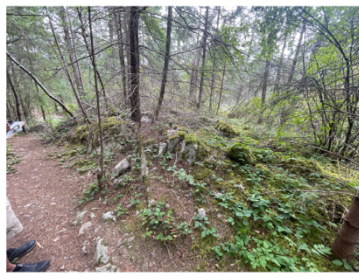
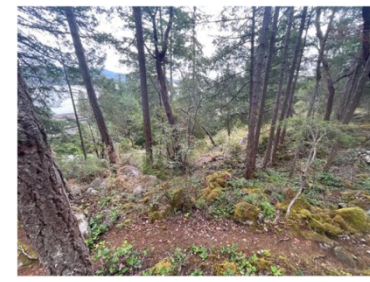
11 As per Golder (1983): "Slope treatment is needed." GES concurs with this recommendation. More broken rocks, indicative of previous rock sliding.

10 Gulley featuring remnant boulders from previous rock sliding

9 Broken rocks from previous rock sliding

7 Evidence of previous rock slide

Figure 3: Map of the subject site, focused on the upper lots. Overlay done by GES.
